# **ASHFIELD COUNCIL**

**ORDINARY MEETING - 26 APRIL 2016**

# Pre-construction Asset Condition Survey – Ashfield Council

## Pre-Construction Road Condition Report- Ashfield Council Road

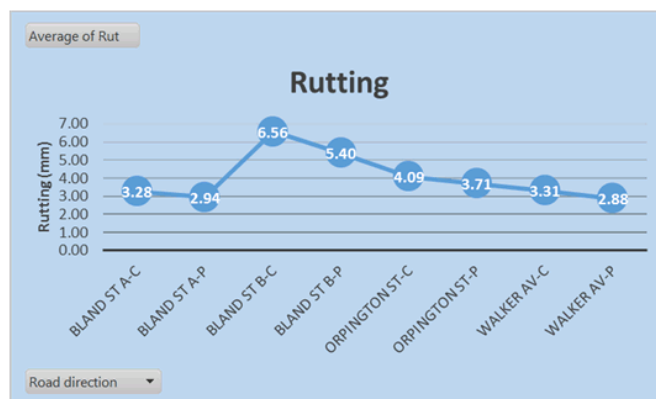
Figure 2.2: Rutting condition

Figure 2.2 presents the average rutting of each road direction and the most rutted is BLAND ST B-C where the worst spot presents rut depth of 6.56mm (Table 2.2 ).

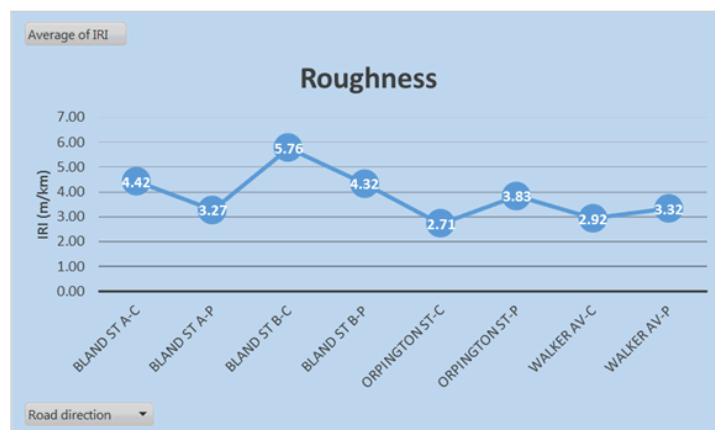
Figure 2.3: Roughness condition

All roads present roughness value of larger than around 3 IRI or higher, while BLAND ST B-C holds the worst section of roughness with 6.56 IRI (Table 2.2 ). Figure 2.3 shows the average roughness condition of each road and BLAND ST B-C is of the most concern in terms of roughness.

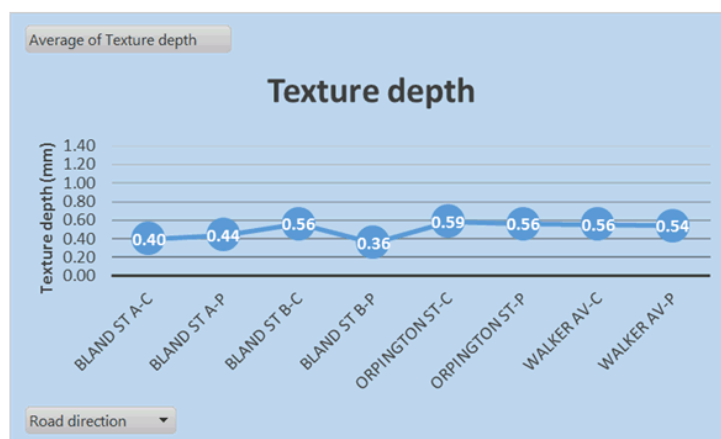
Figure 2.4: Texture depth

As indicated in Figure 2.4 , all roads present similar texture depth while BLAND ST B-P appears to be higher than the rest in terms of average values, and the most concerned spot also exists on BLAND ST B-P. Table 2.2 shows the worst condition spot over the selected roads.

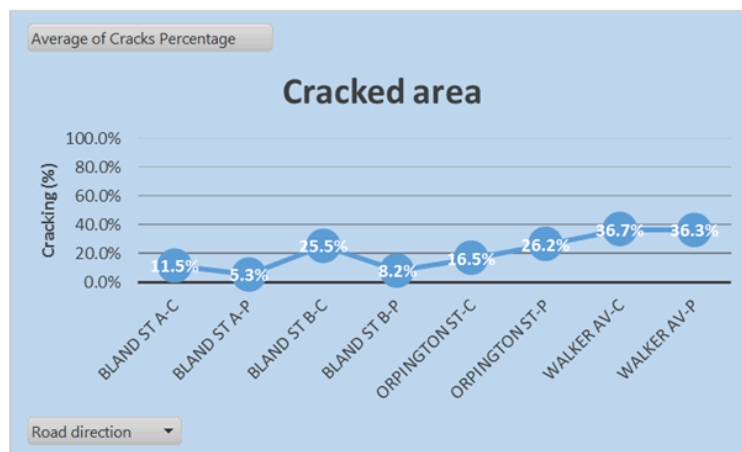
Figure 2.5: Cracking condition

While all four roads are cracked, WALKER AV in both directions appear to be the most cracked road with an average cracked area of 36.5% and the mostly cracked section is also found on WALKER AV with 60% area cracked (Table 2.2).

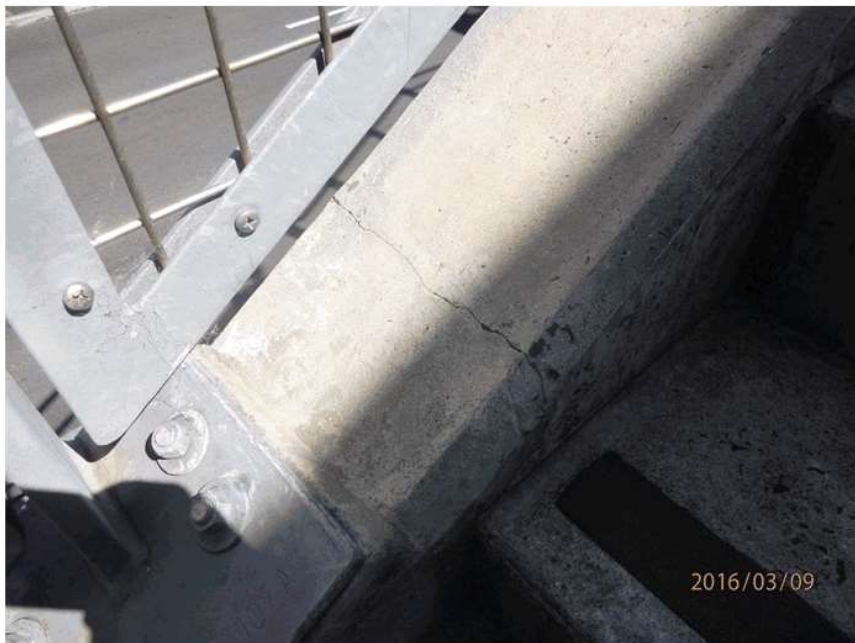
Bland Street Pedestrian Bridge – cracked northern staircase

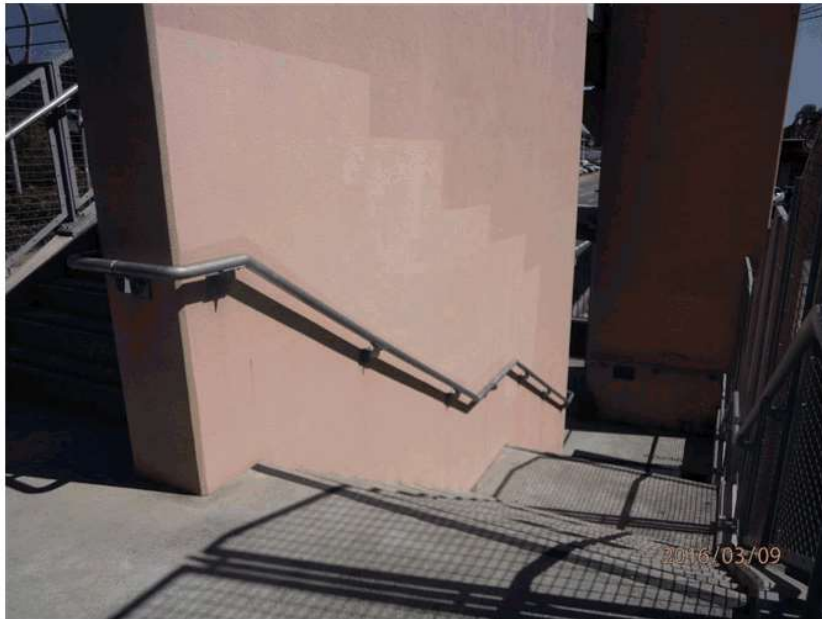
Bland Street Pedestrian Bridge – cracked northern staircase

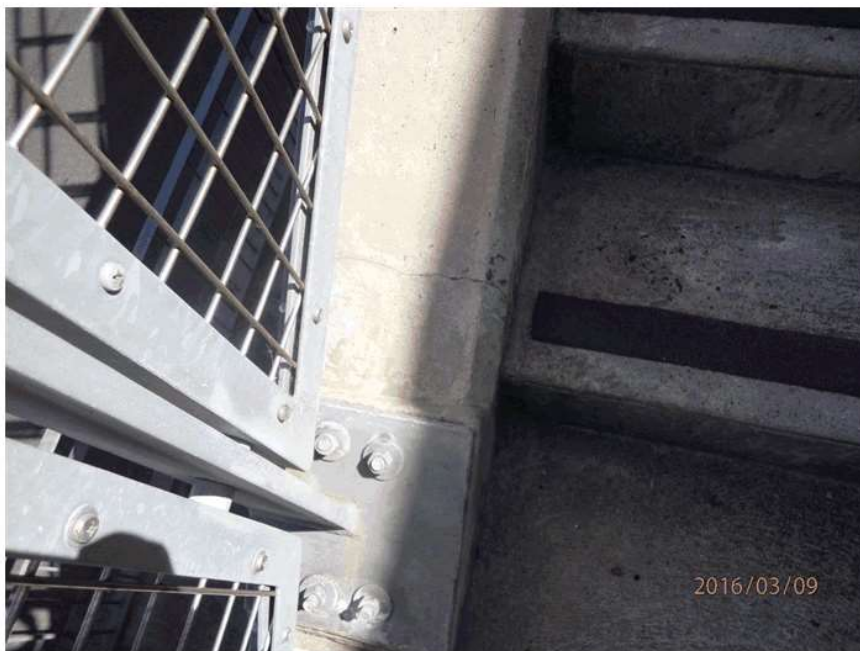
Bland Street Pedestrian Bridge – cracked northern staircase

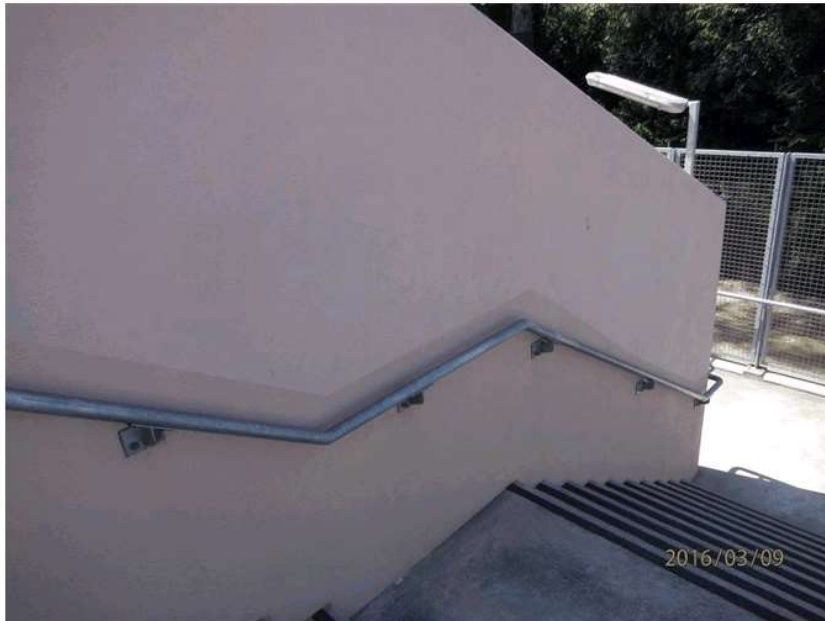
Bland Street Pedestrian Bridge – cracked northern staircase

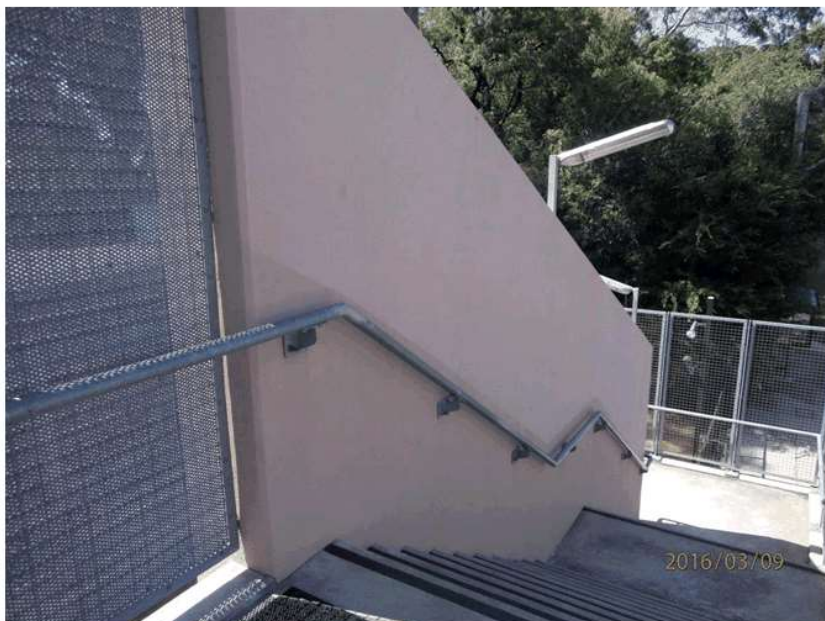
Bland Street Pedestrian Bridge – cracked northern staircase
