# **ASHFIELD COUNCIL**

**ORDINARY MEETING - 26 APRIL 2016**

# Pre-construction Asset Condition Survey – Ashfield Council

## Pre-Construction Road Condition Report- Ashfield Council Road

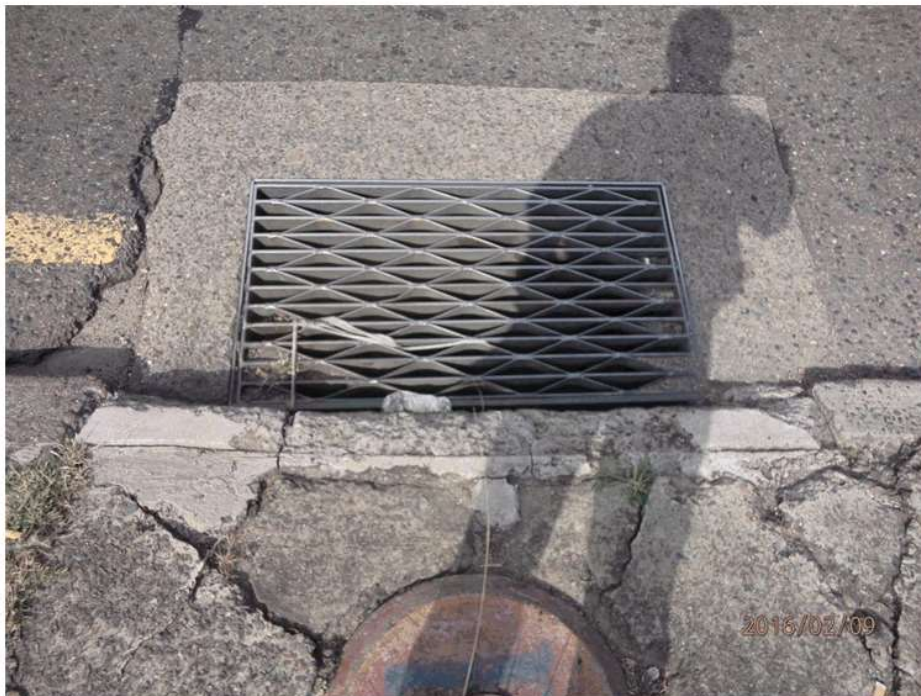
Stormwater drain at DP-070 - Wolseley southbound and Parramatta Road intersection

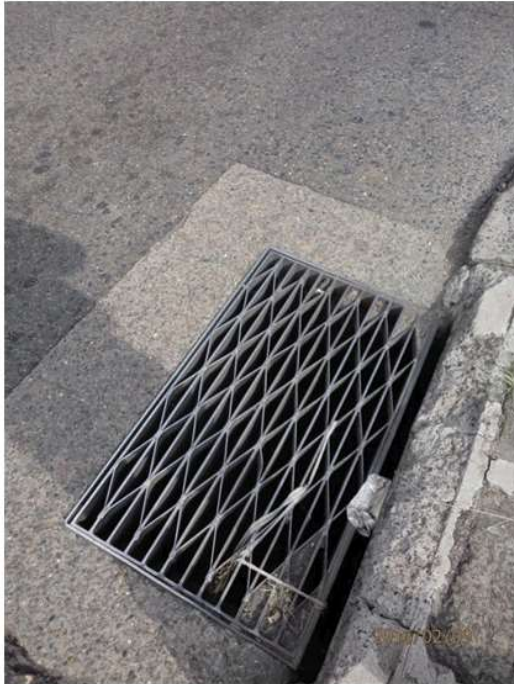
Stormwater drain at DP-070 - Woleseley southbound and Parramatta Road intersection

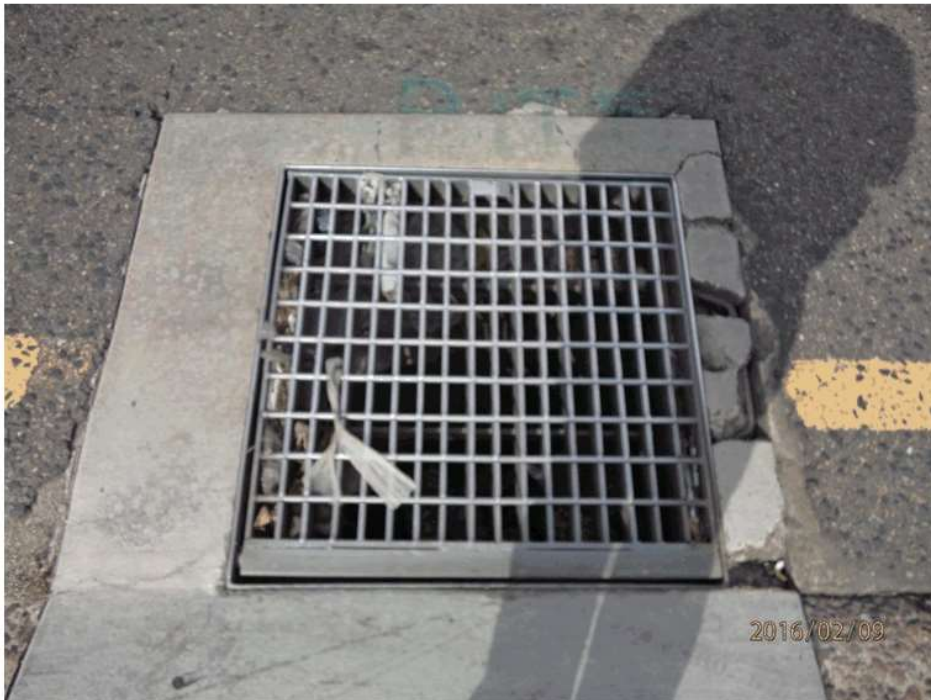
Stormwater drain at DP-070 western corner end of Woleseley and Parramatta Road.

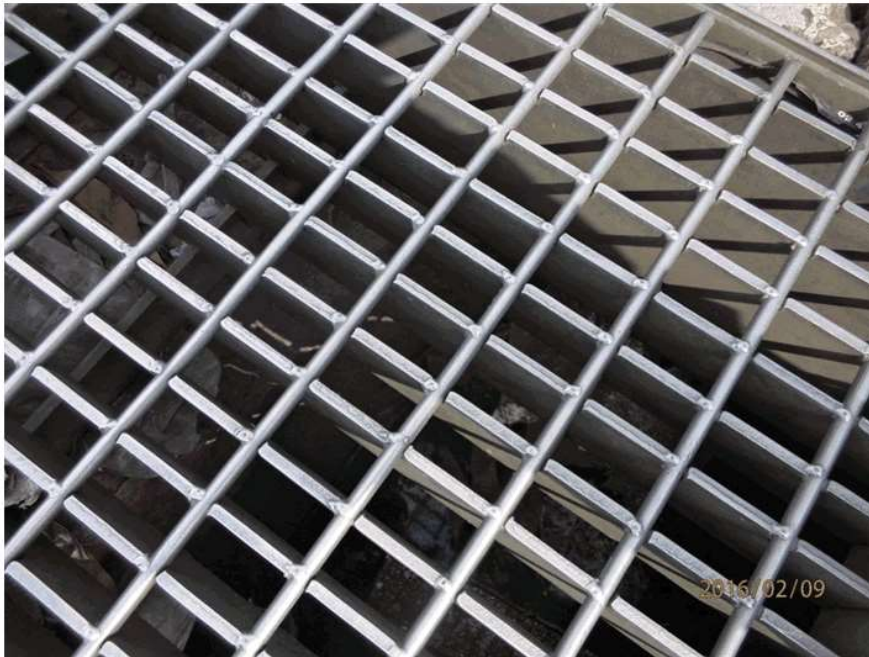
Stormwater drain at DP-070 western corner end of Wolseley and Parramatta Road.

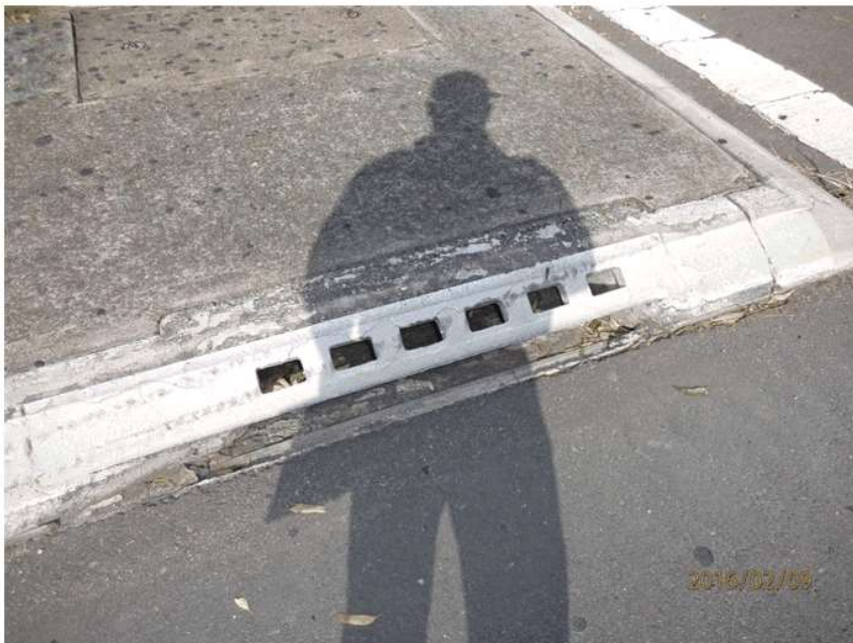
Stormwater drain downstream from DP-080 – Parramatta Rd median strip

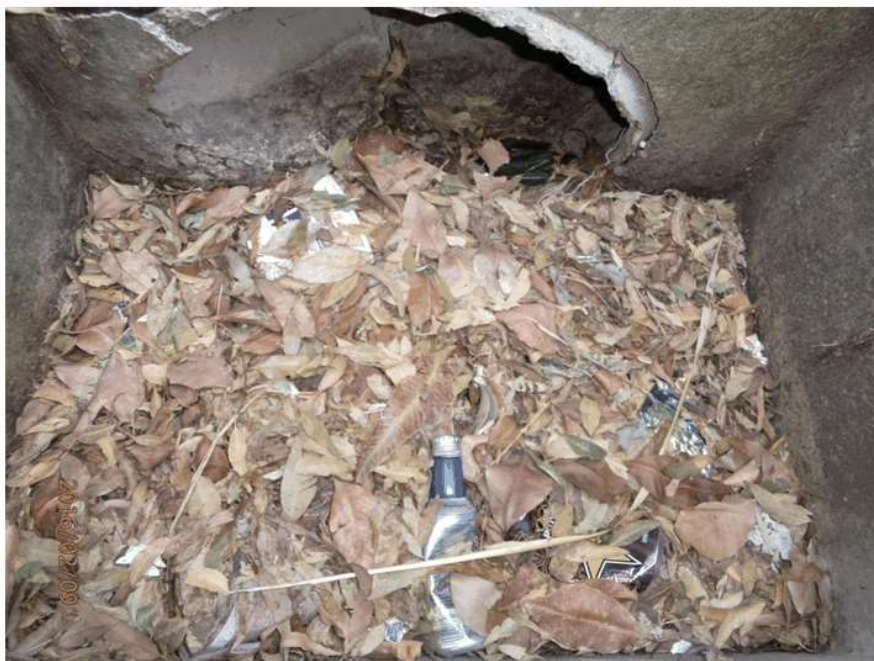
Stormwater drain at DP-080 – Pit and outlet

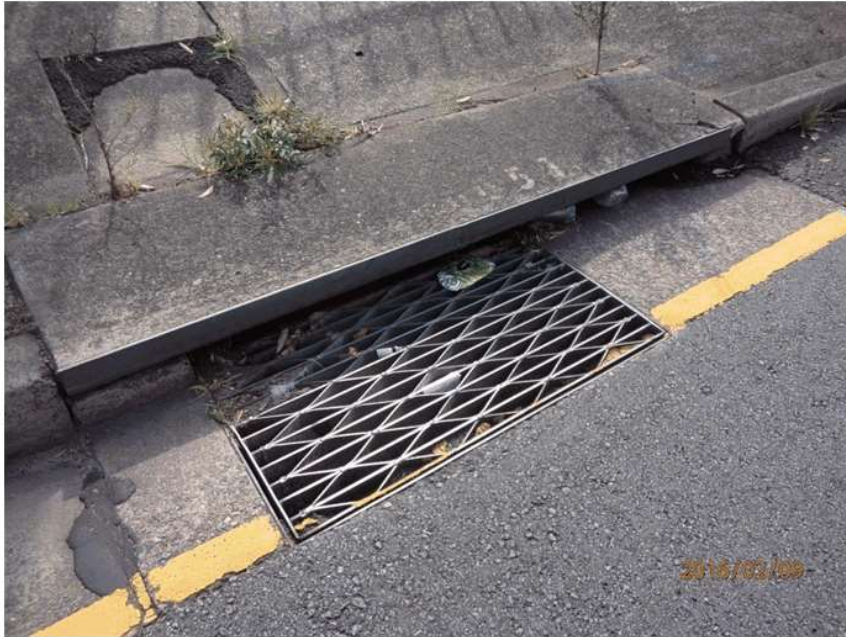
Stormwater drain downstream from DP-080 – Wattle Parramatta Road westbound

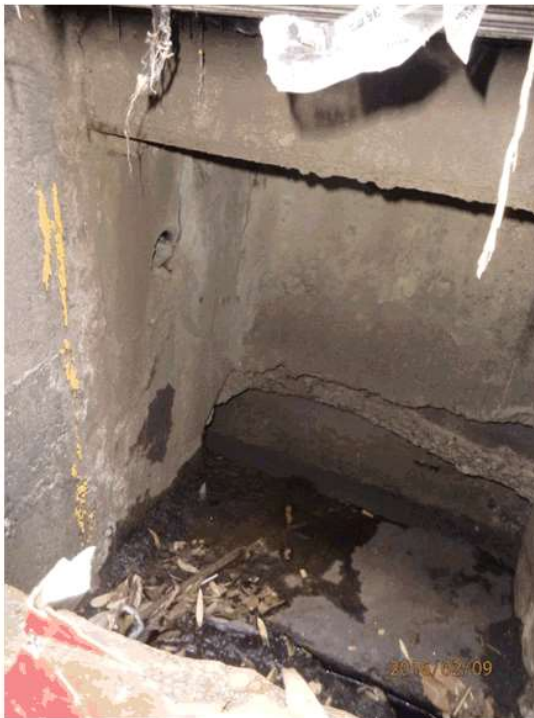
Stormwater drain downstream from DP-080 – Pit and outlet

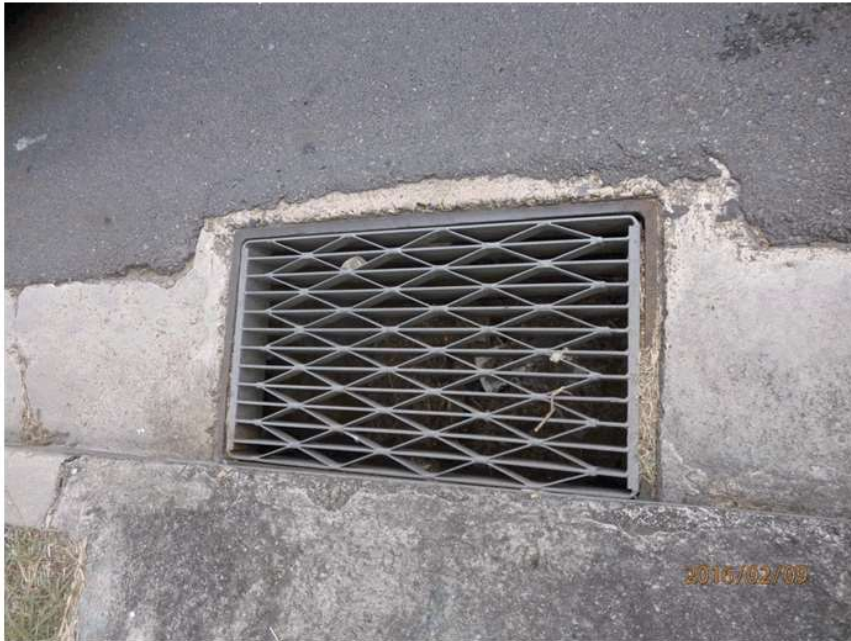
Drain at DP-090 – Wattle Street Westbound

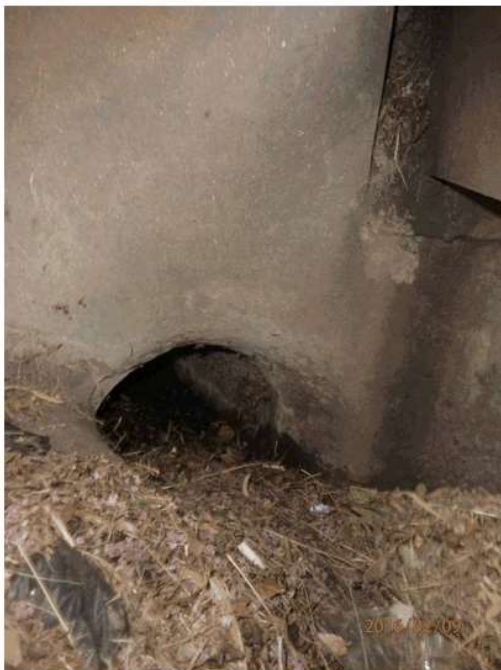
Stormwater drain pit and outlet

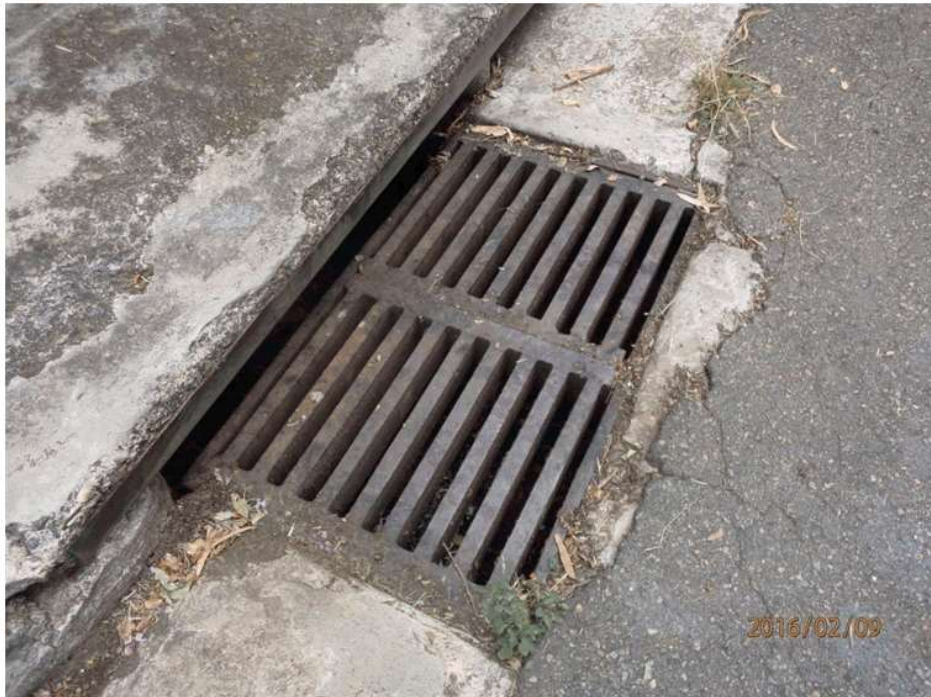
Stormwater drain downstream from DP-090 – Wattle Street westbound and Allum Street

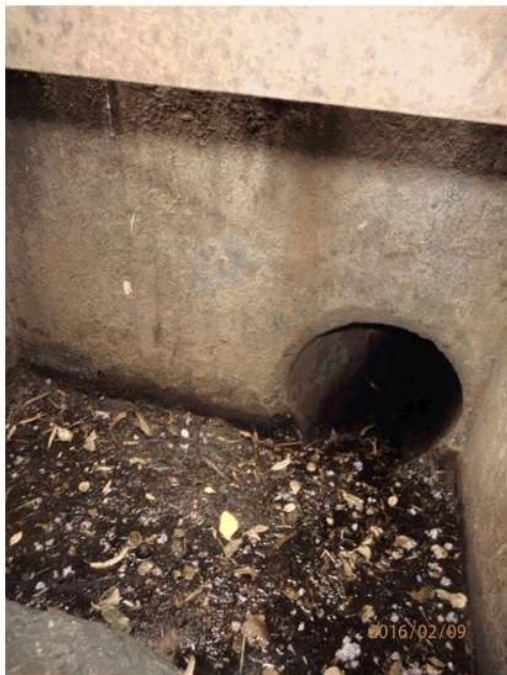
Stormwater drain pit and outlet downstream from DP-090

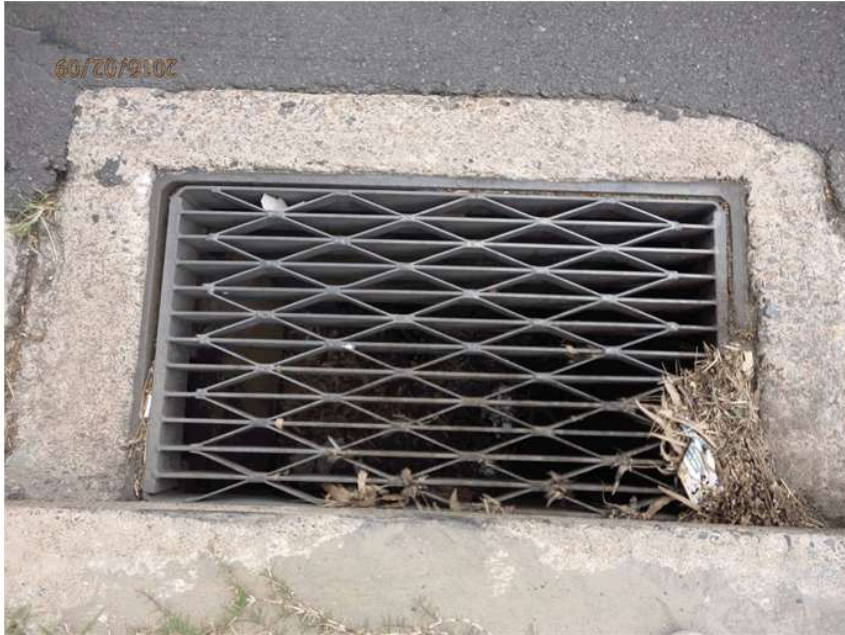
Stormwater drain past Allum Street Wattle street junction. \*Unable to photograph outlets as lid opening too small.

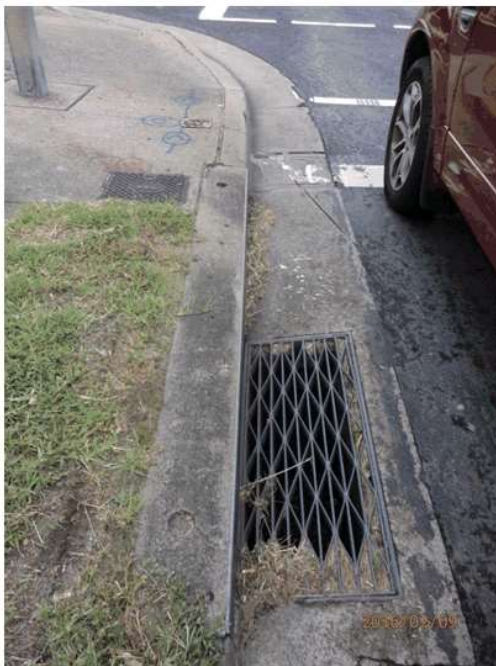
Stormwater drain downstream from DP-091 (across Ramsey Street Intersection)

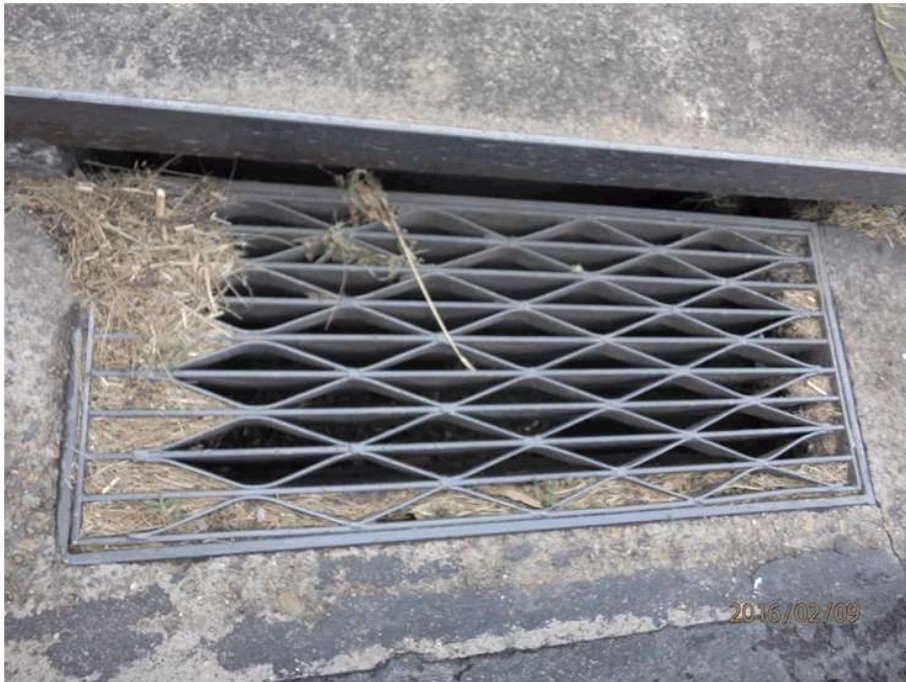
Stormwater drain downstream from DP-091 (across Ramsey Street Intersection)

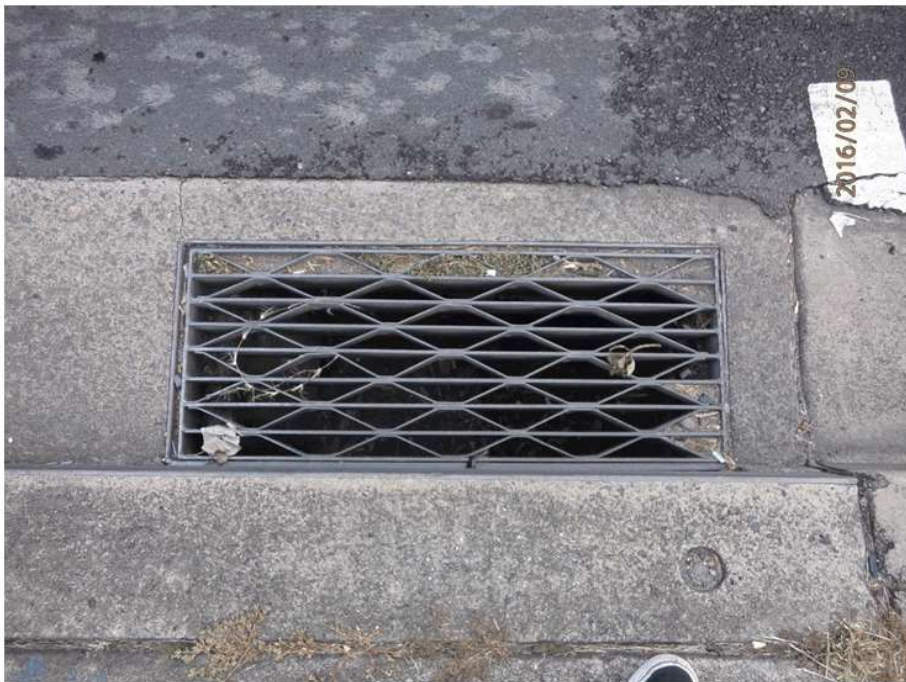
Stormwater drain downstream from DP-091 (before Ramsey Street Intersection)

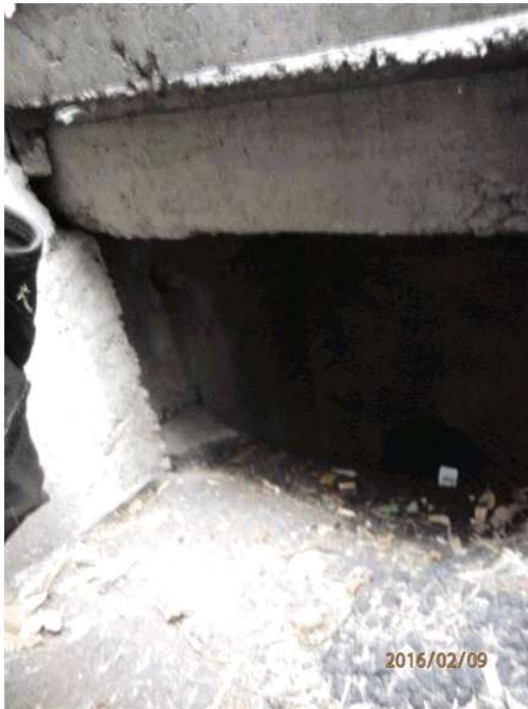
Drain Pit and outlet

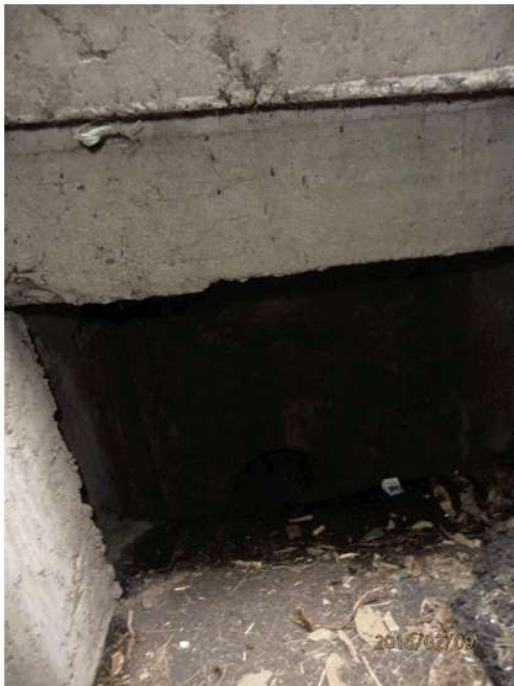
Drain Pit and outlet

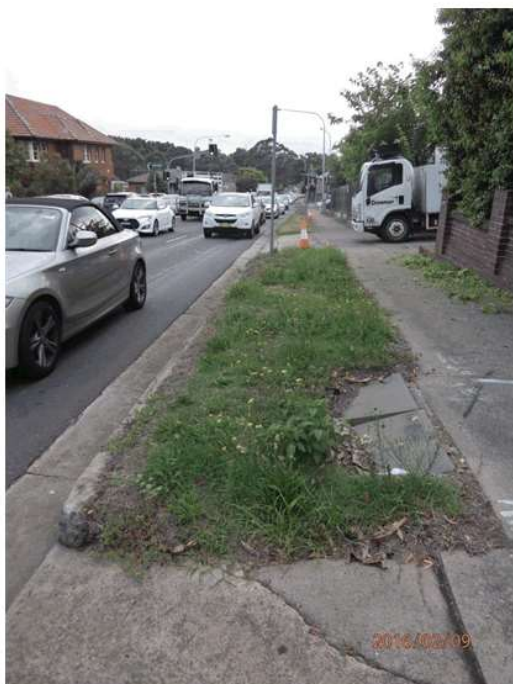
Approximate location of DP-091 upstream from documented drains

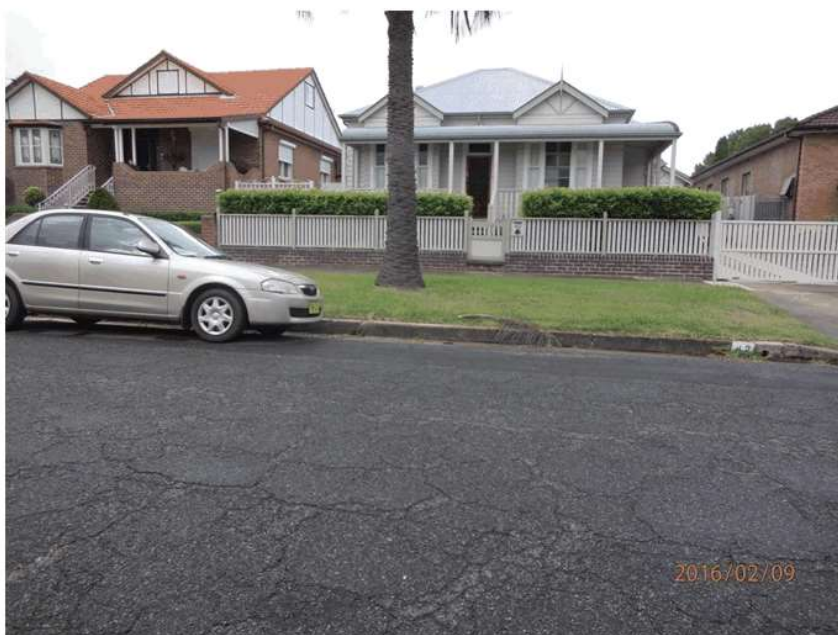
Approximate location of discharge point DP-052

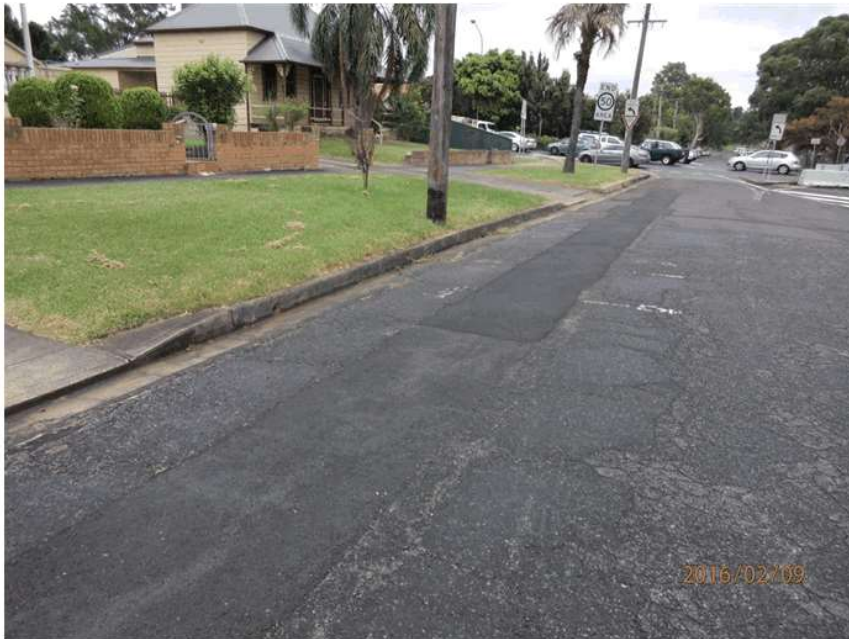
Downstream of DP-052

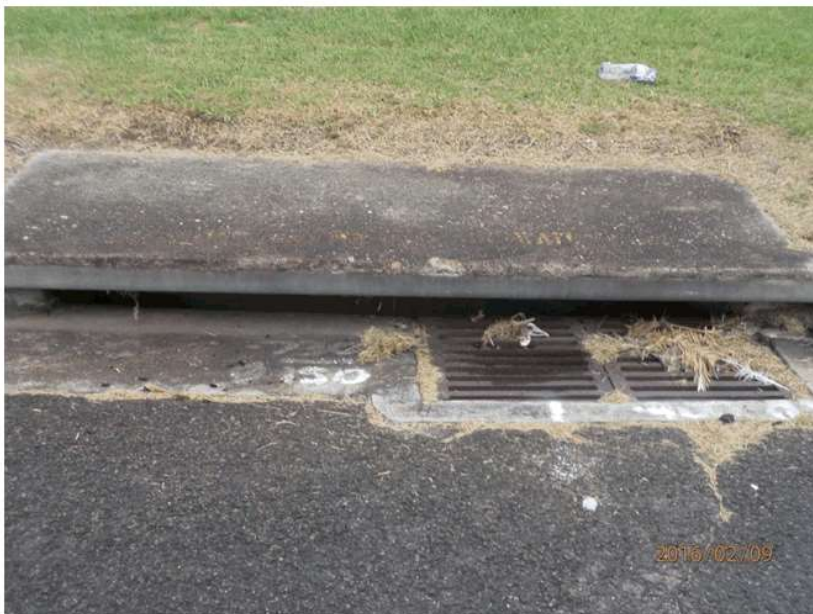
Stormwater drain downstream from DP-052

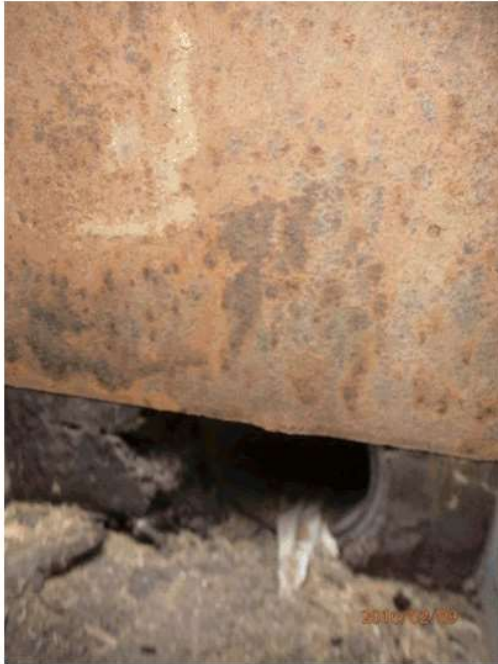
Drain outlet appears to be unblocked.

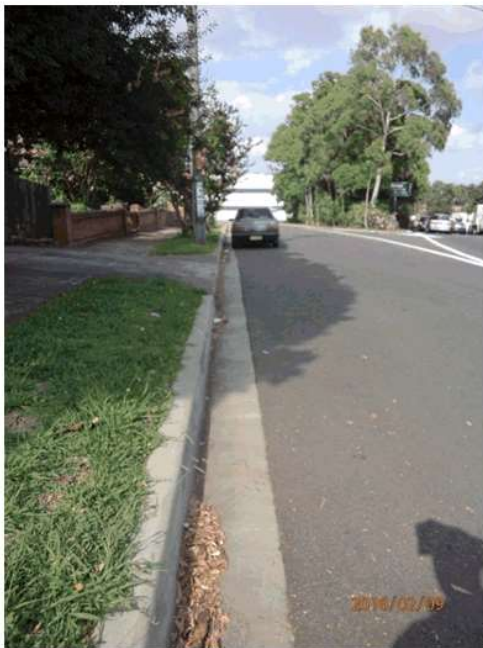
Location of DP-093 – Closest Drain that at DP-080

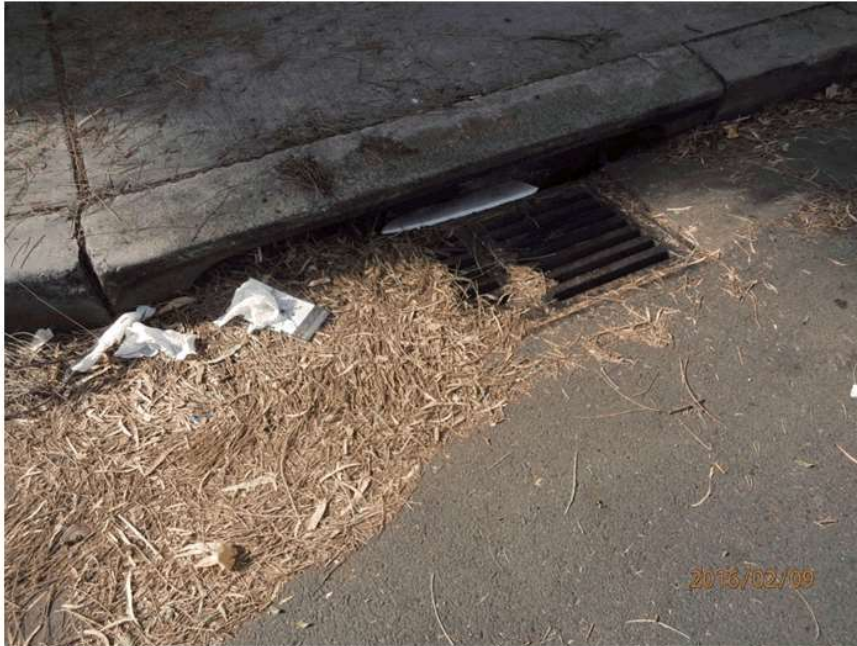
Stormwater drain downstream from DP-100.

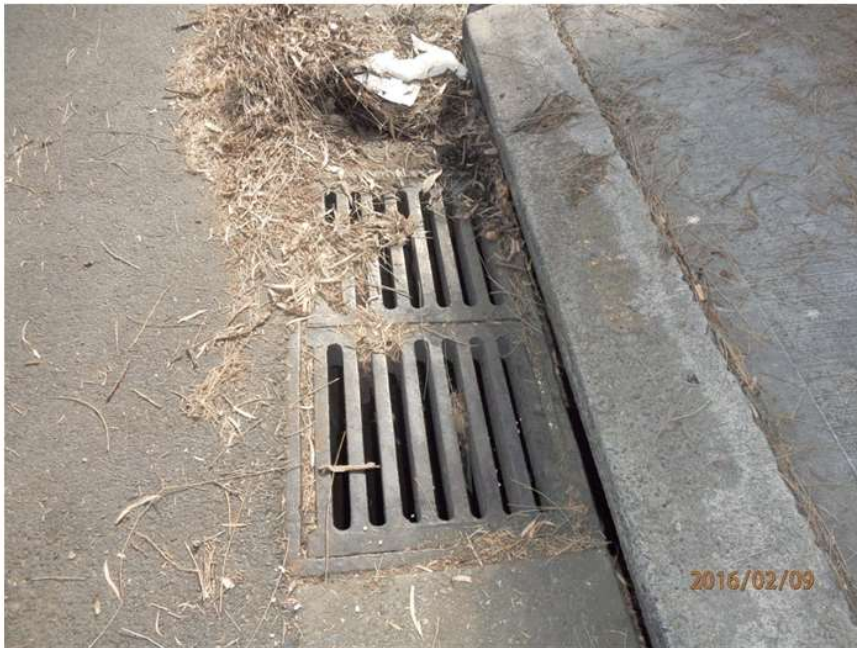
Stormwater drain downstream from DP-100.

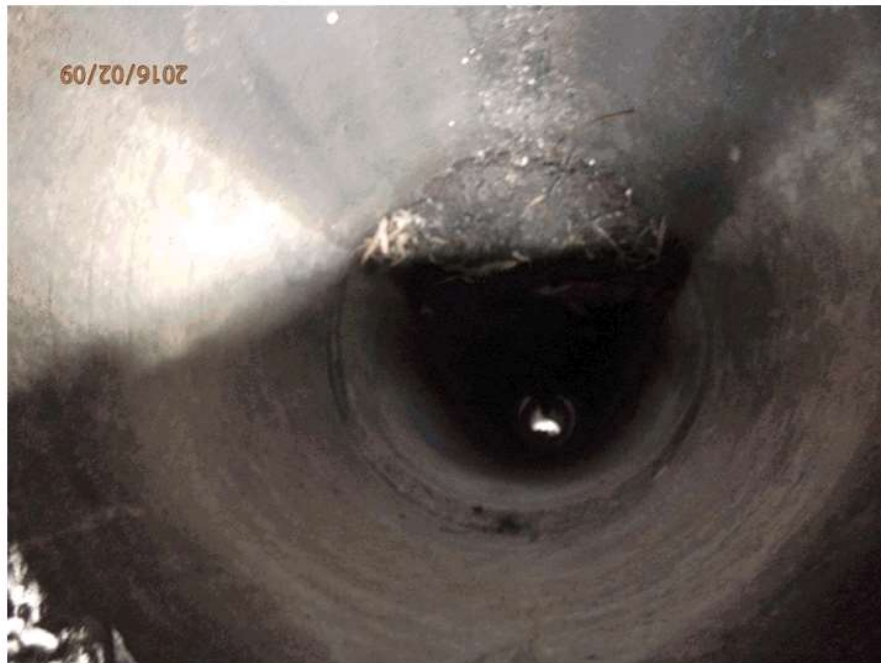
Stormwater DP100 - Drain outlet

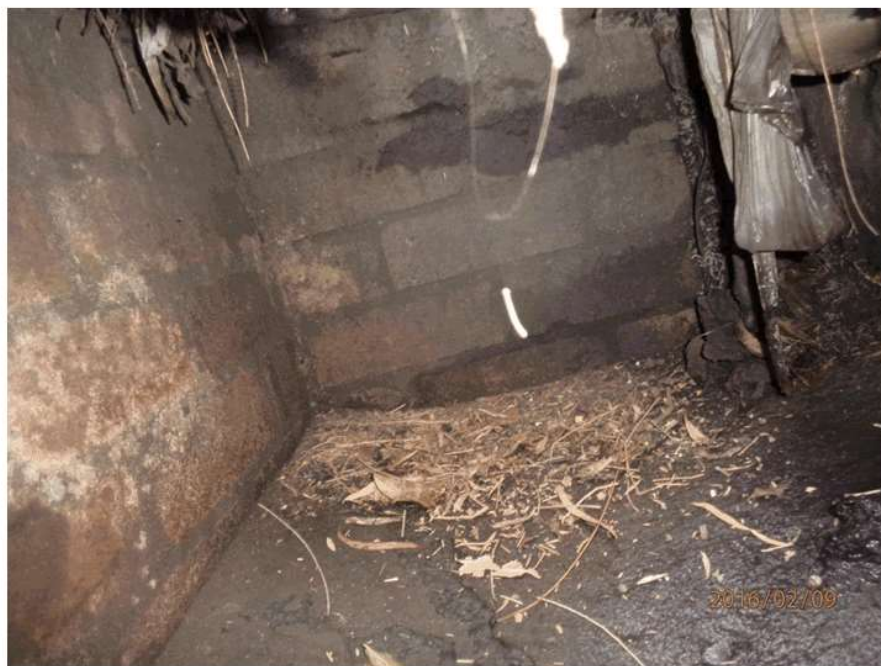
Stormwater DP100 – Drain pit

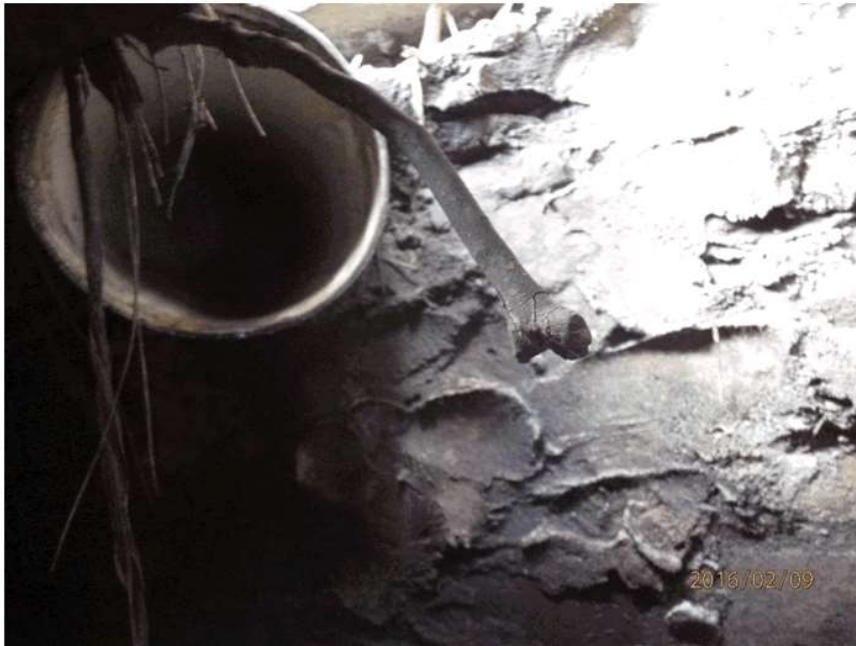
Stormwater DP100 - Drain inlet

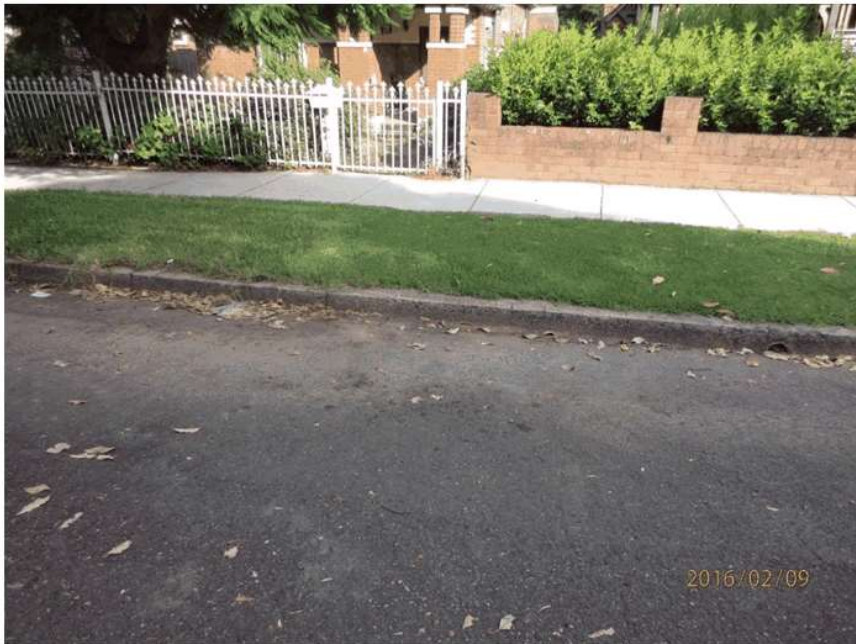
Location of DP-101

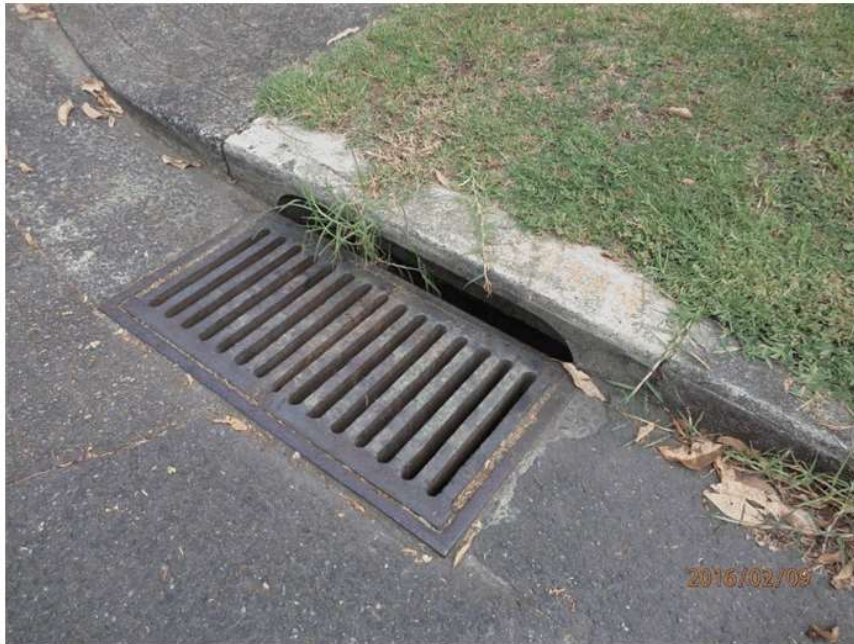
Stormwater drain downstream from DP-101 – Chandos Street Curt Street junction

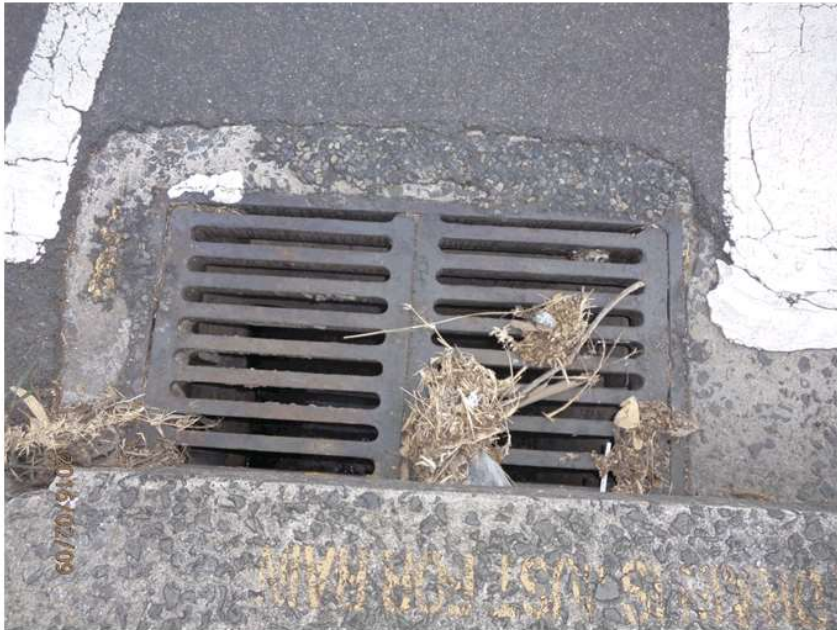
Stormwater drain at DP-102 on Bland Street and Parramatta Road Intersection

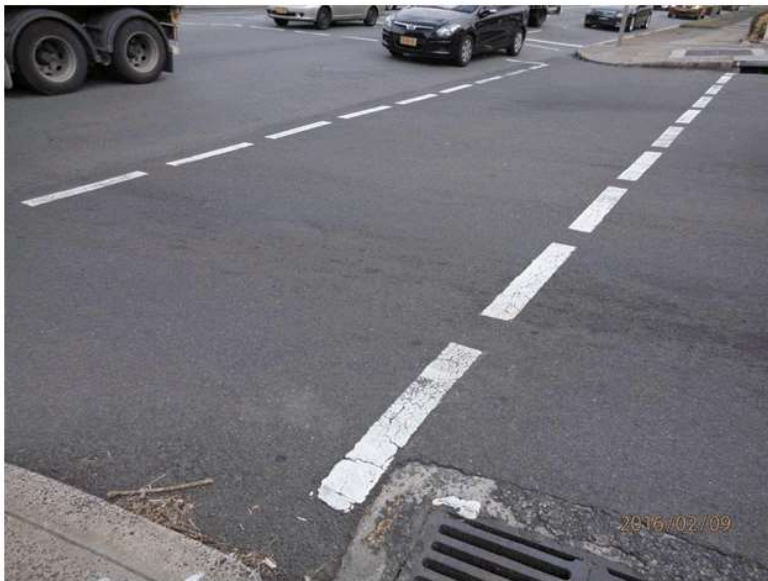
Downstream from DP-102

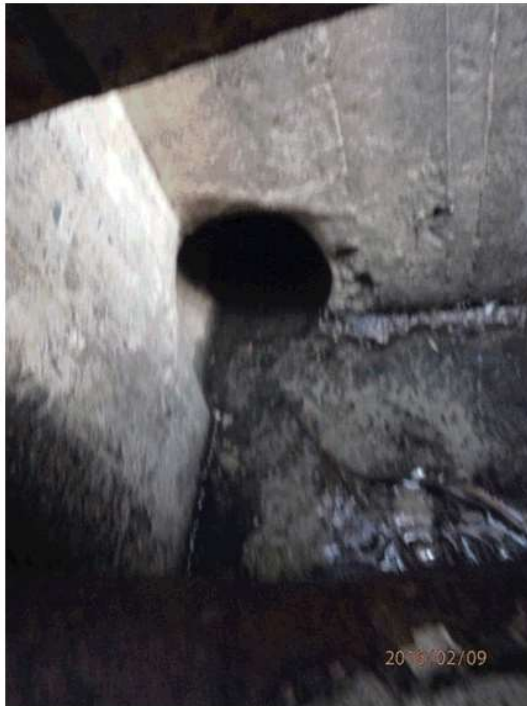
Outlet in stormwater drain at DP-102 on Bland Street and Parramatta Road Intersection

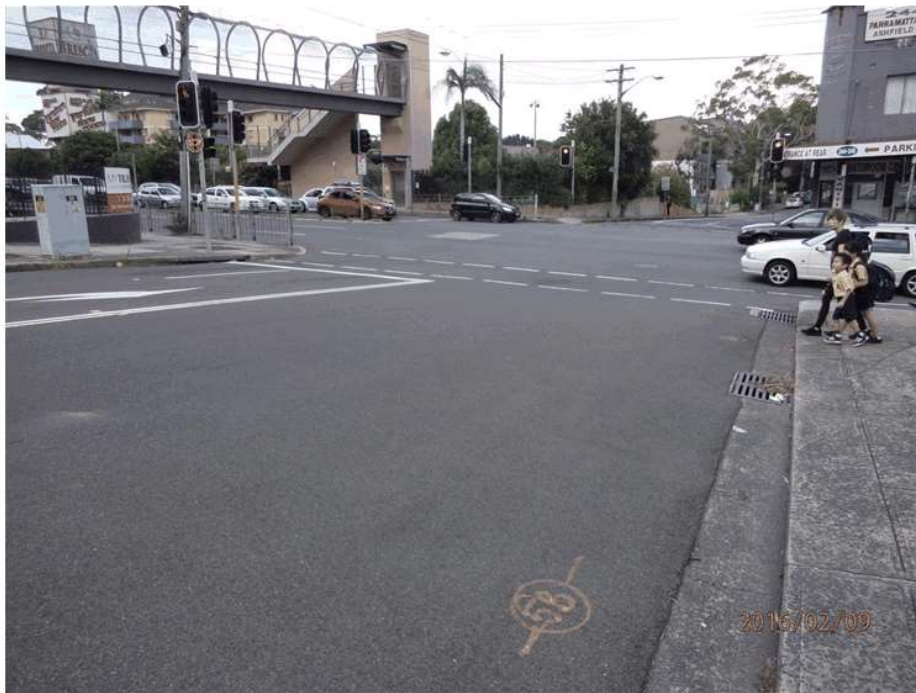
Downstream from DP-102

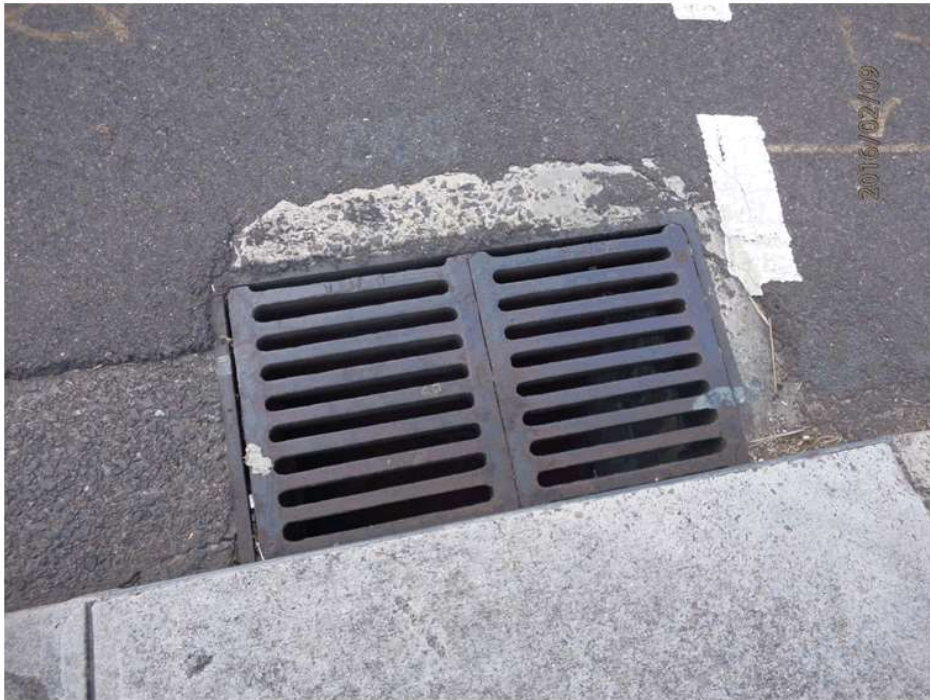
Stormwater drain downstream from DP-102 (opposite side of Parramatta Road)

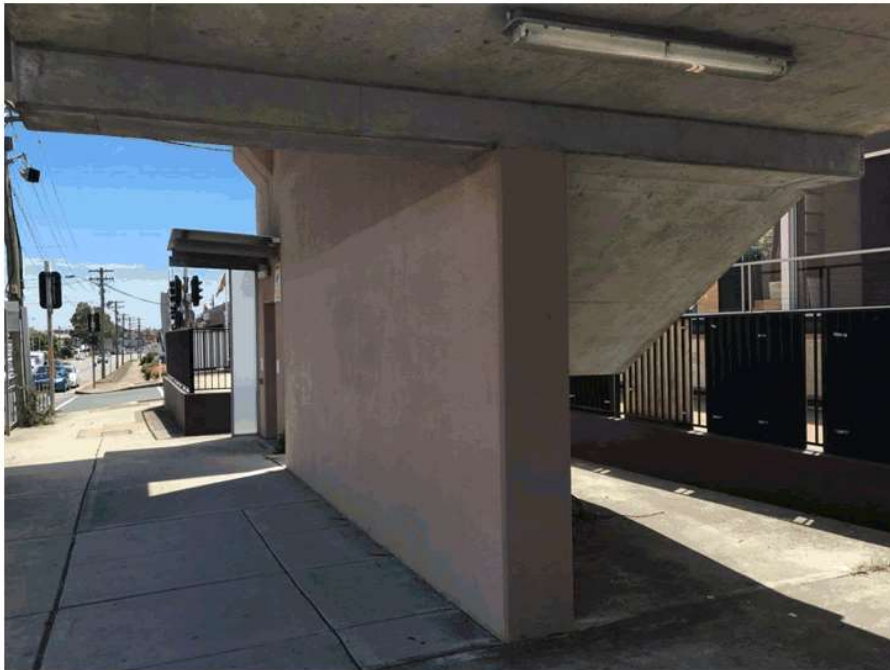
Bland Street Pedestrian Bridge – Northern access support

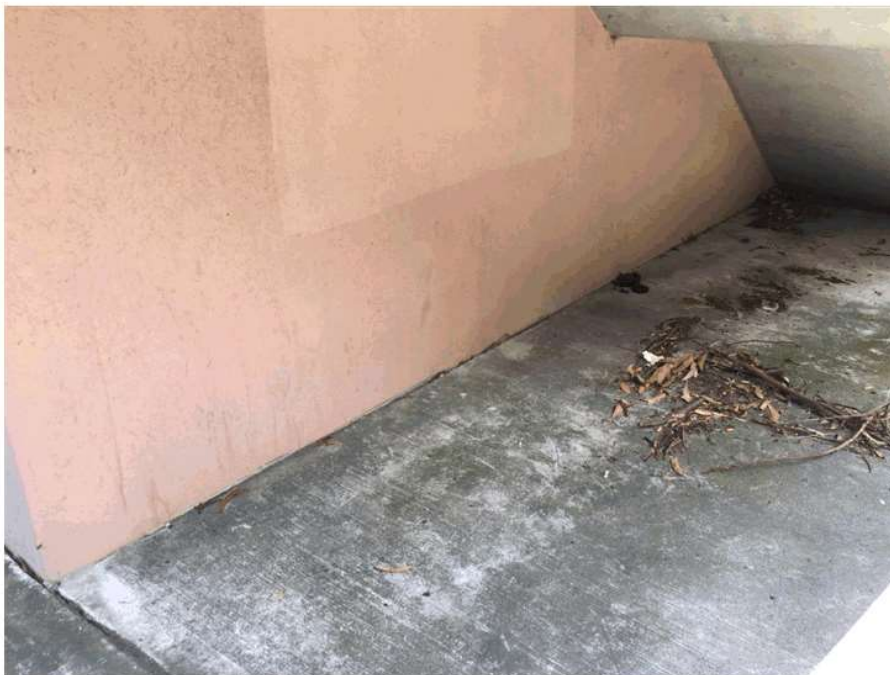
Bland Street Pedestrian Bridge – Northern access support

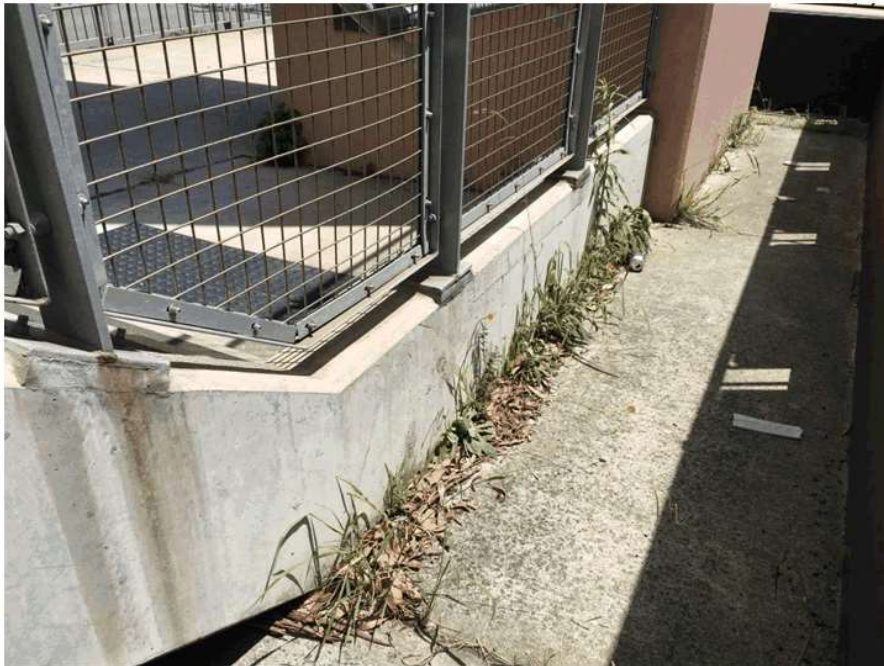
Bland Street Pedestrian Bridge – Northern access structure

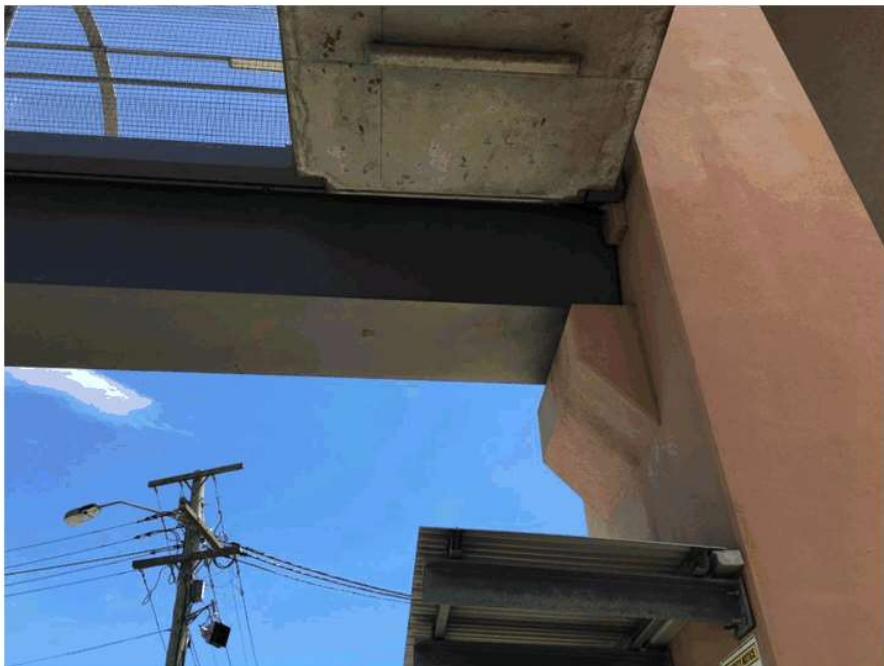
Bland Street Pedestrian Bridge – Northern abutment

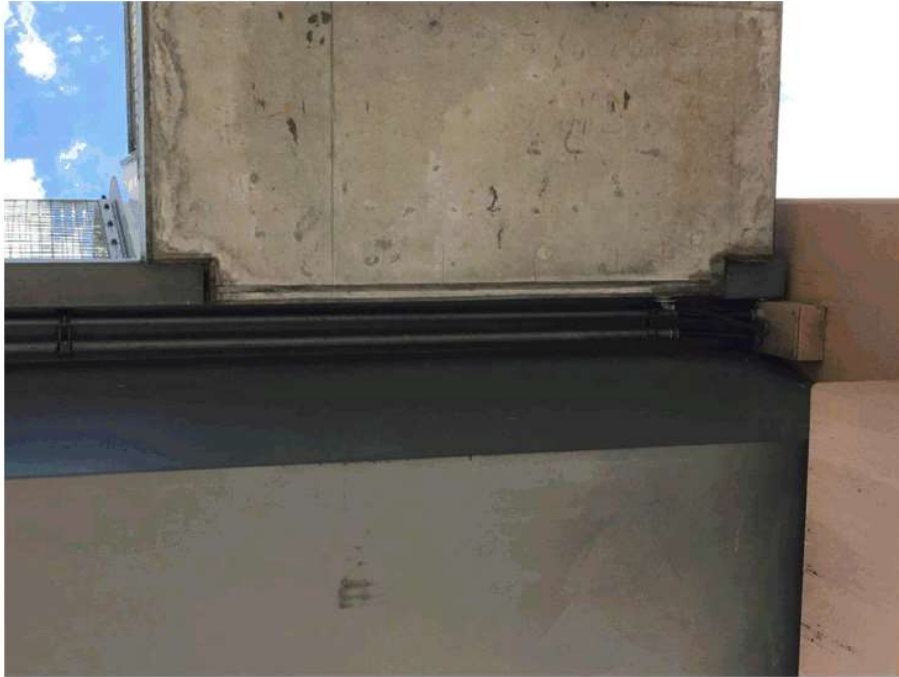
Bland Street Pedestrian Bridge – Northern abutment

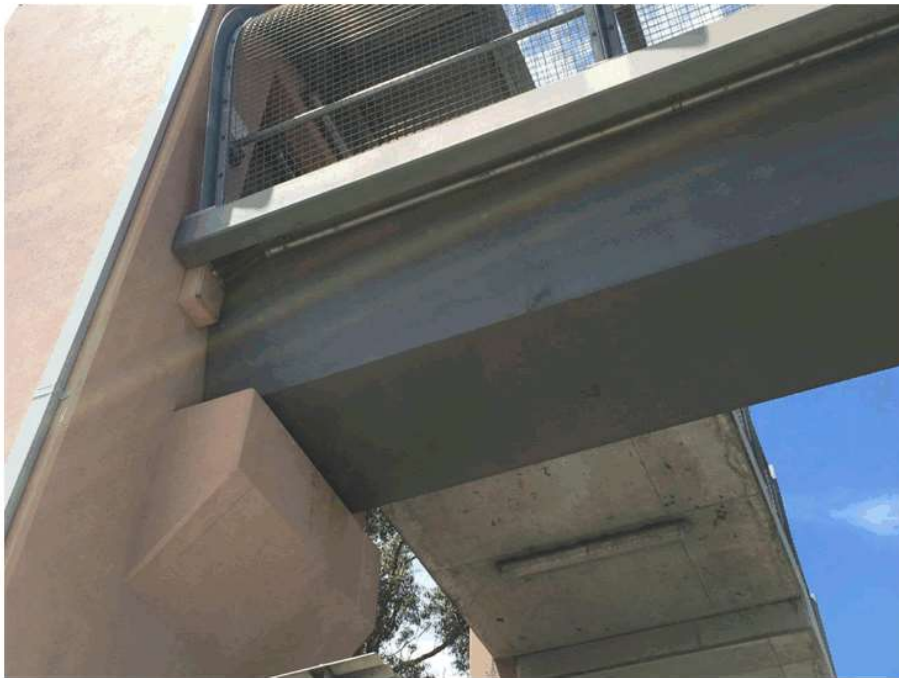
Bland Street Pedestrian Bridge – Northern abutment

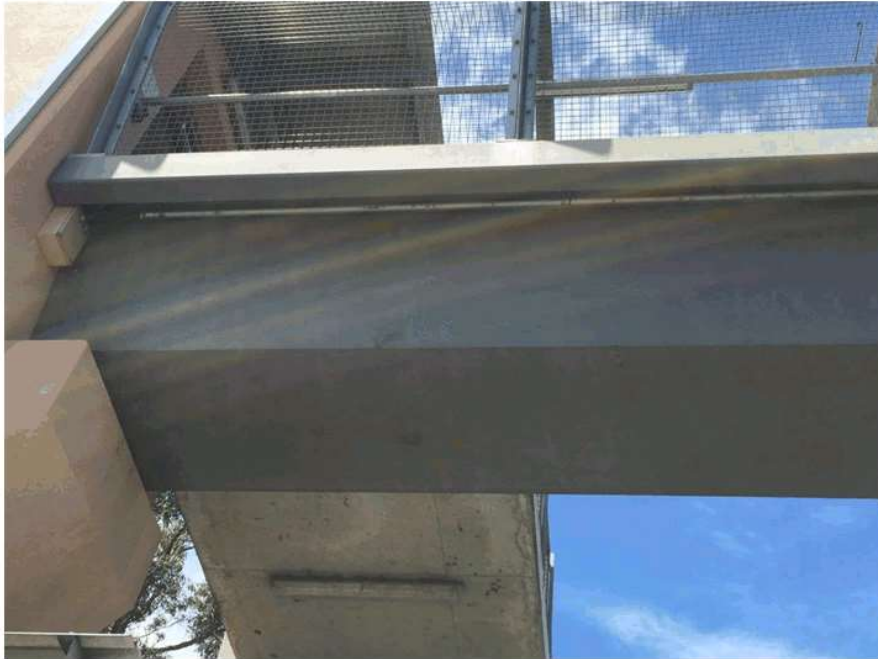
Bland Street Pedestrian Bridge – walkway span 1 of 4
