# **ASHFIELD COUNCIL**

**ORDINARY MEETING - 26 APRIL 2016**

# Pre-construction Asset Condition Survey – Ashfield Council

## Pre-Construction Road Condition Report- Ashfield Council Road

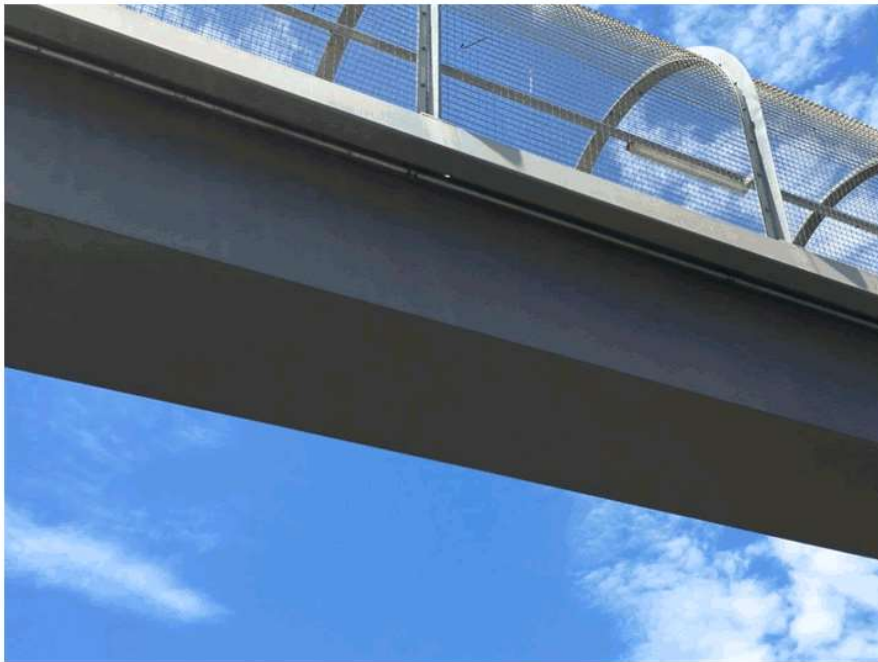
Bland Street Pedestrian Bridge – walkway span 2 of 4

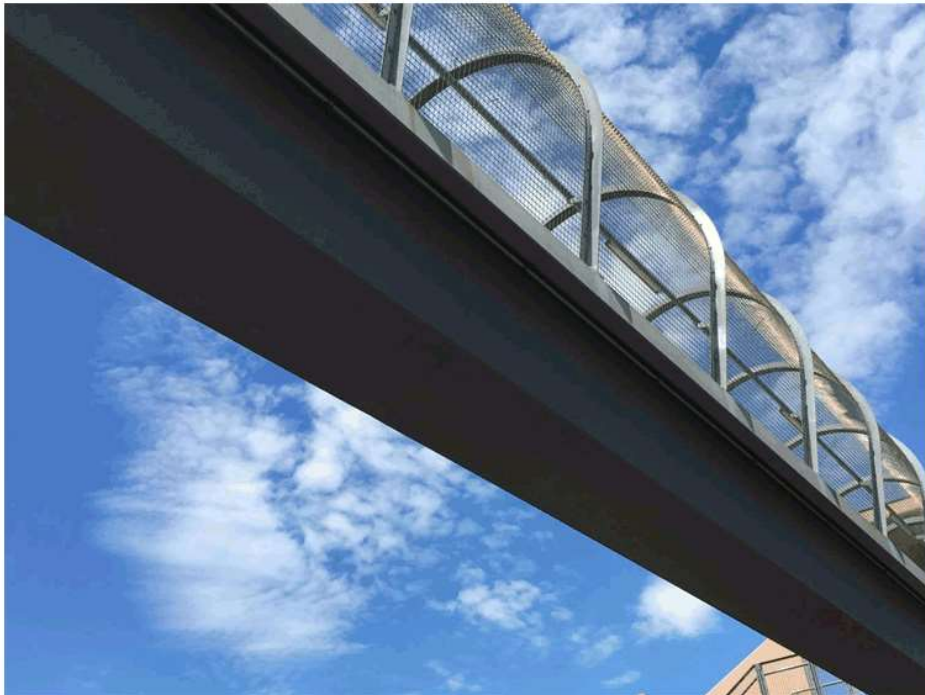
Bland Street Pedestrian Bridge – walkway span 3 of 4

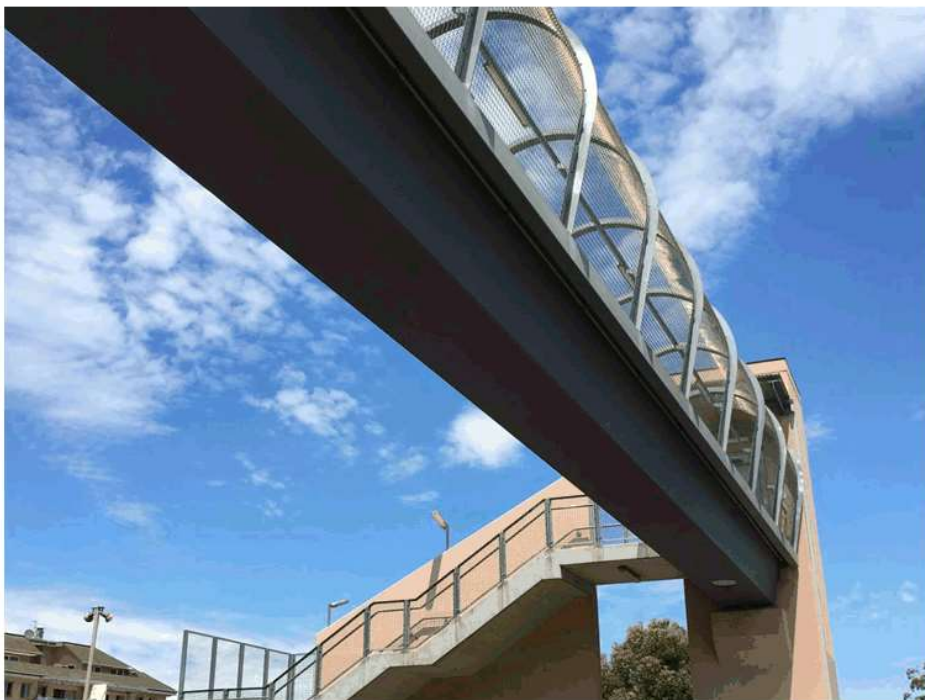
Bland Street Pedestrian Bridge – walkway span 4 of 4

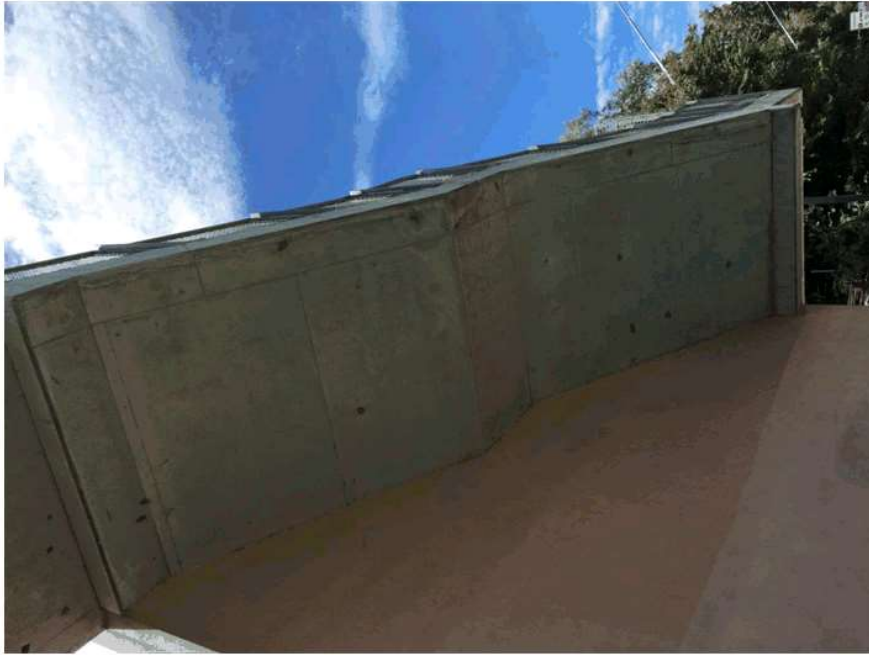
Bland Street Pedestrian Bridge – Northern access stair

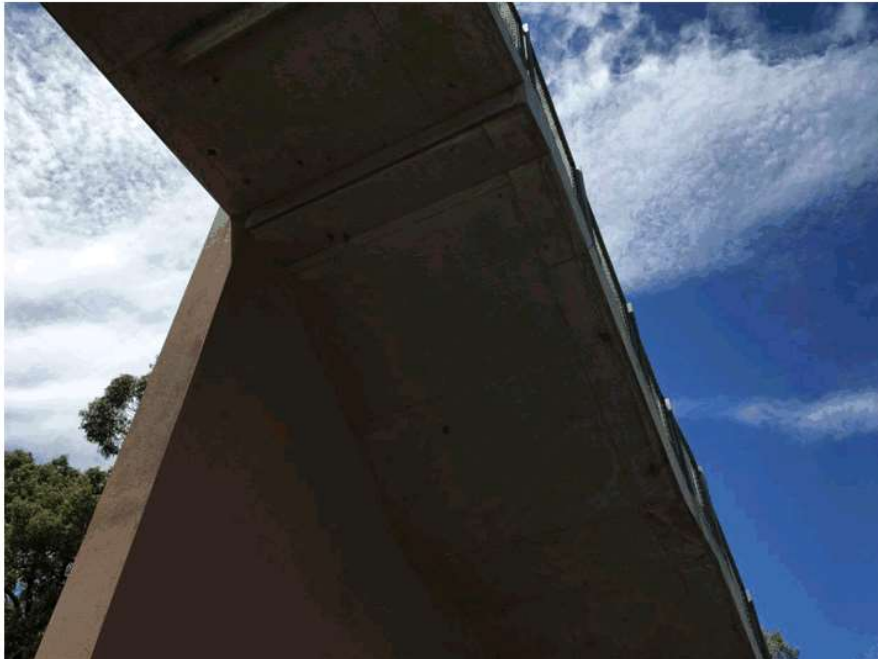
Bland Street Pedestrian Bridge – Northern access stair

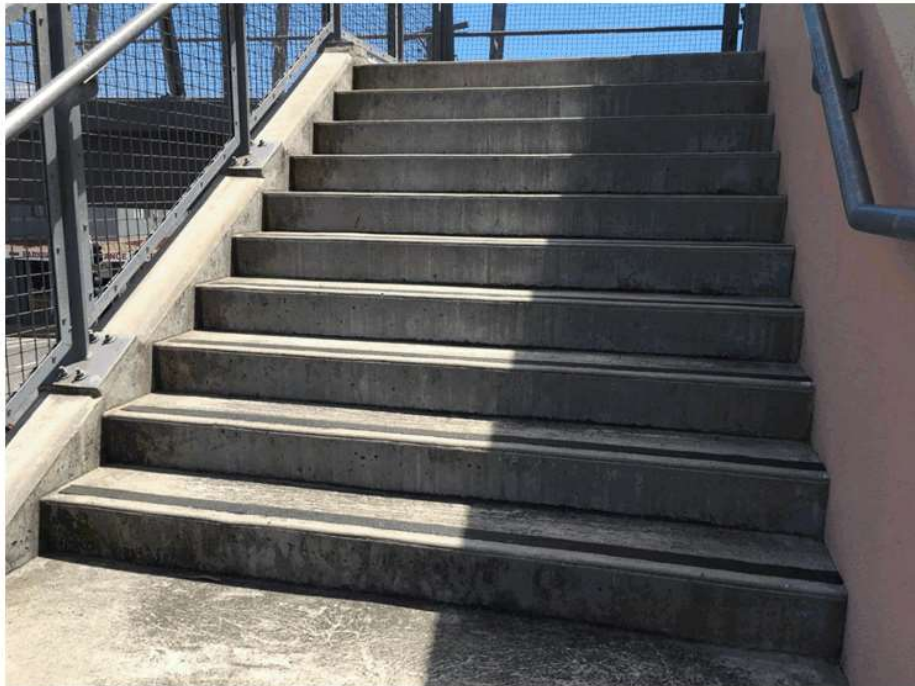
Bland Street Pedestrian Bridge – Northern access stair

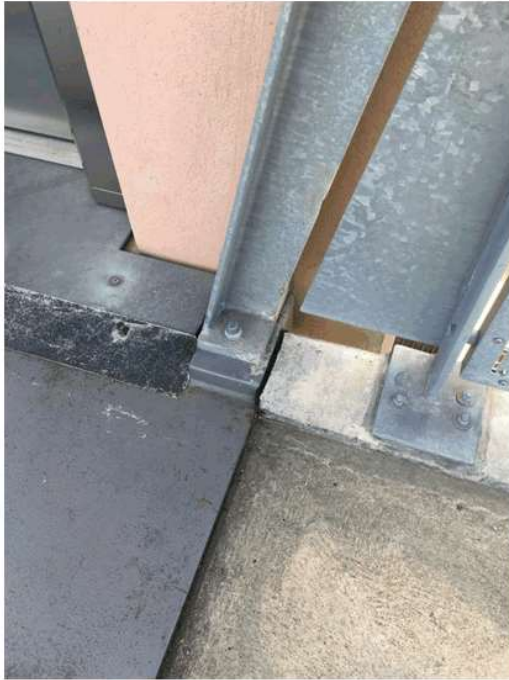
Bland Street Pedestrian Bridge – Northern abutment top view

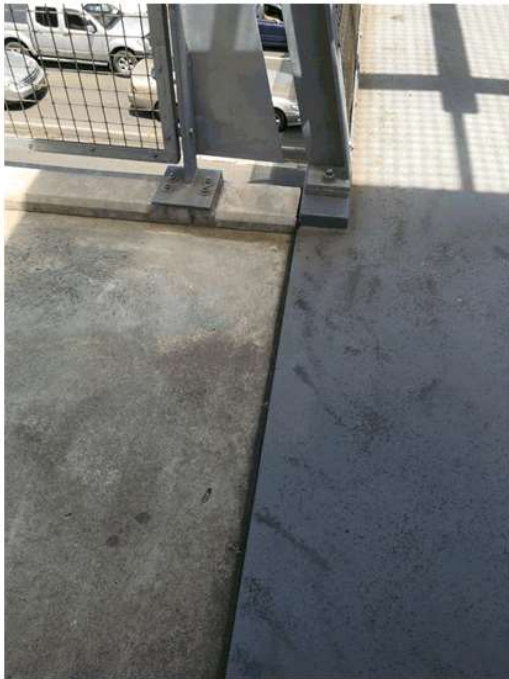
Bland Street Pedestrian Bridge – Northern abutment top view

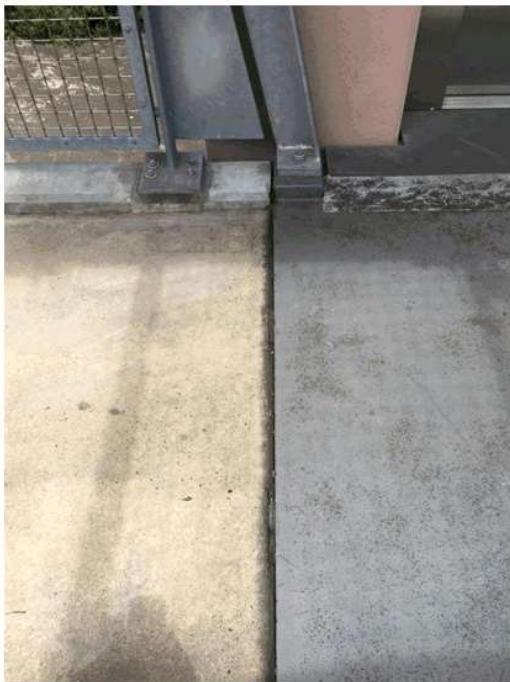
Bland Street Pedestrian Bridge – Southern abutment top view

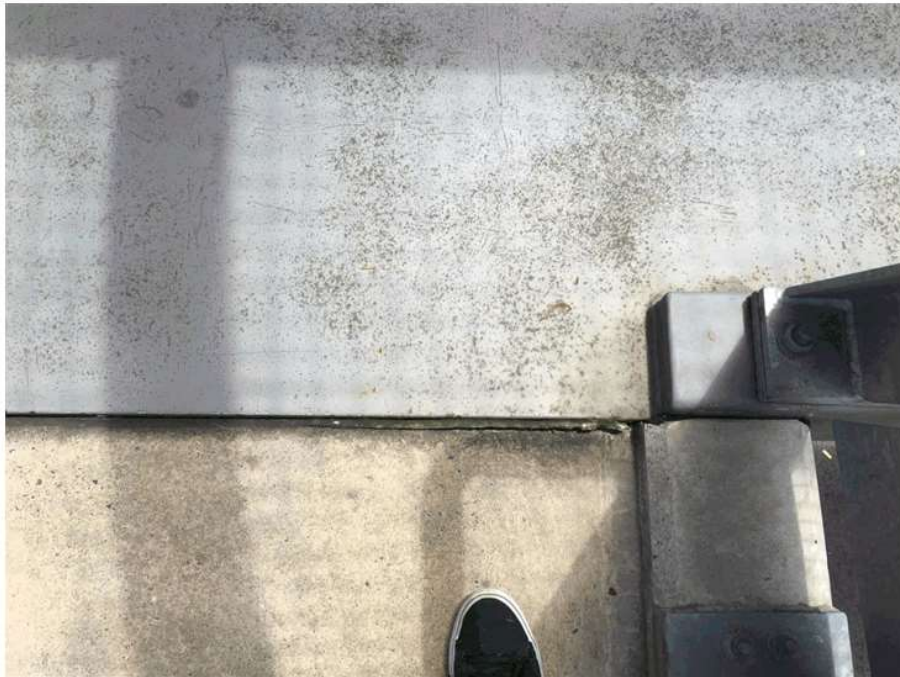
Bland Street Pedestrian Bridge – Southern abutment top view

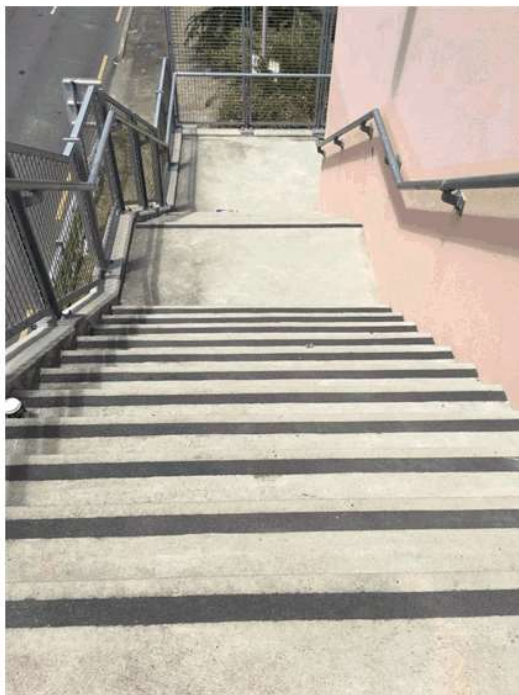
Bland Street Pedestrian Bridge – Southern access stair

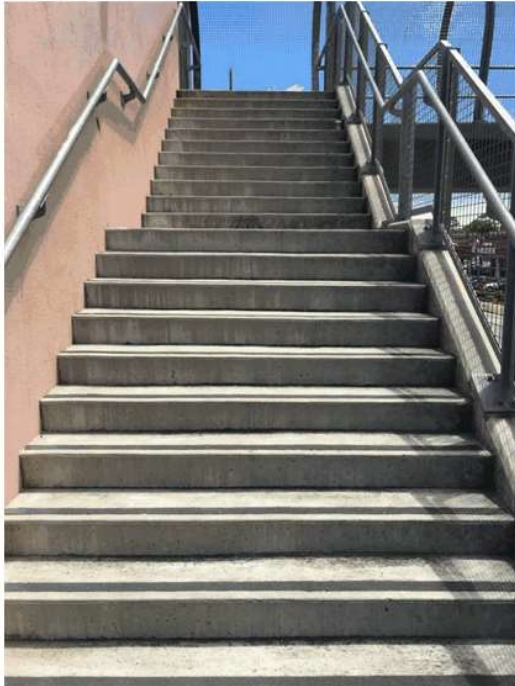
Bland Street Pedestrian Bridge – Southern access stair

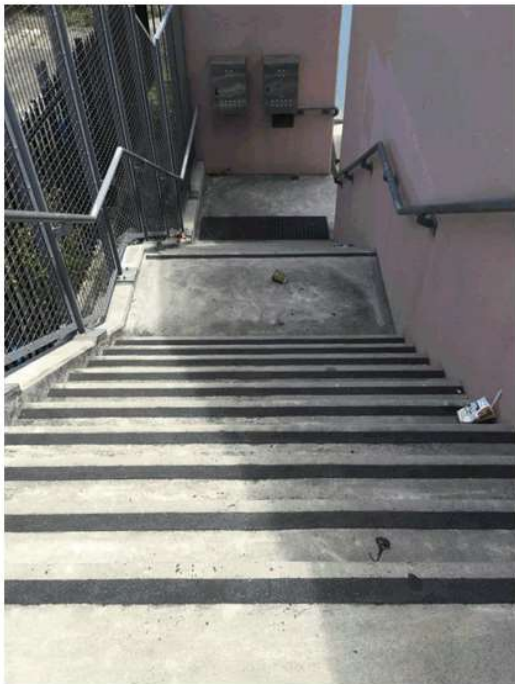
Bland Street Pedestrian Bridge – Southern access stair

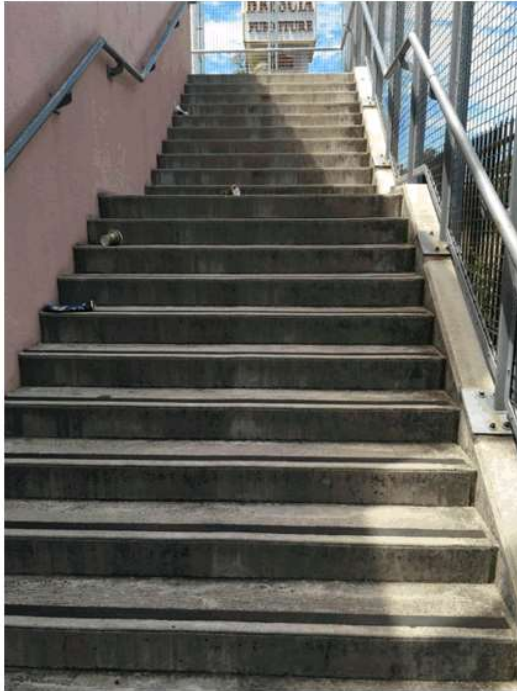
Bland Street Pedestrian Bridge – Southern access stair

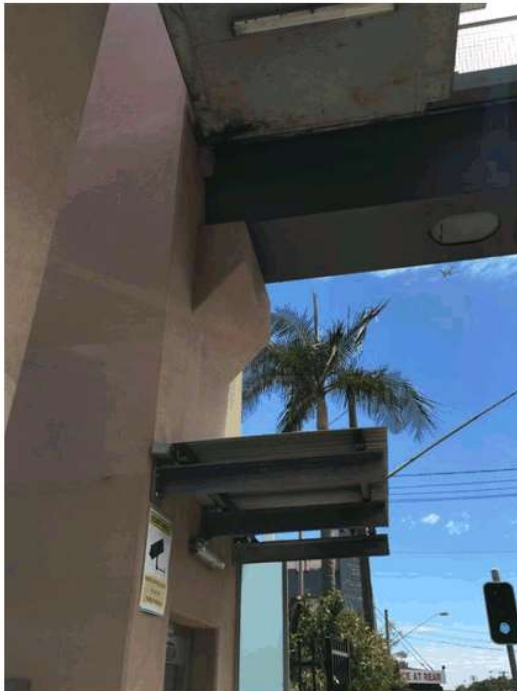
Bland Street Pedestrian Bridge – Southern abutment

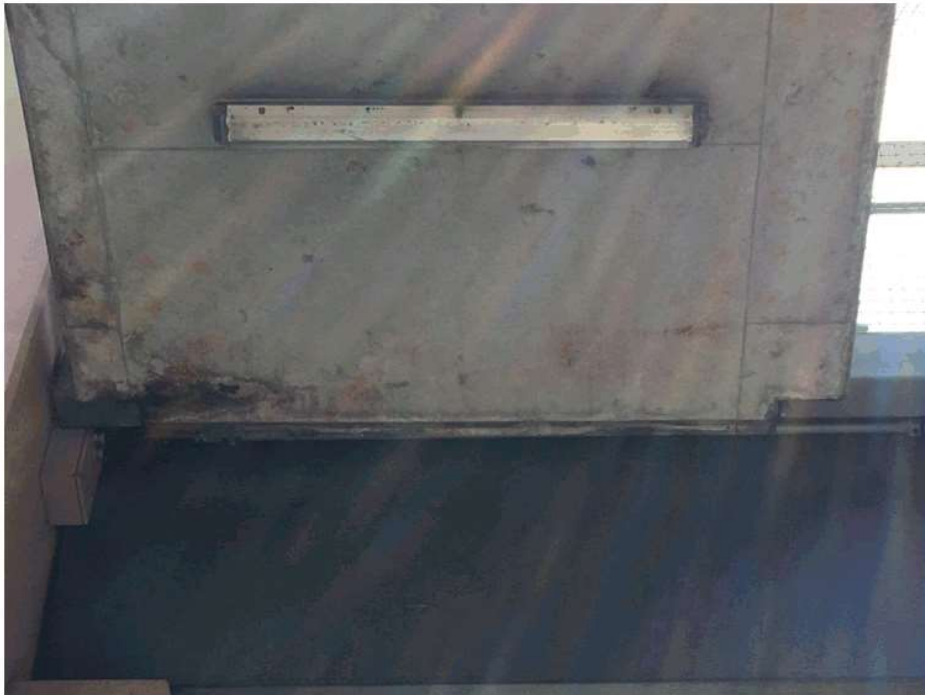
Bland Street Pedestrian Bridge – Southern abutment

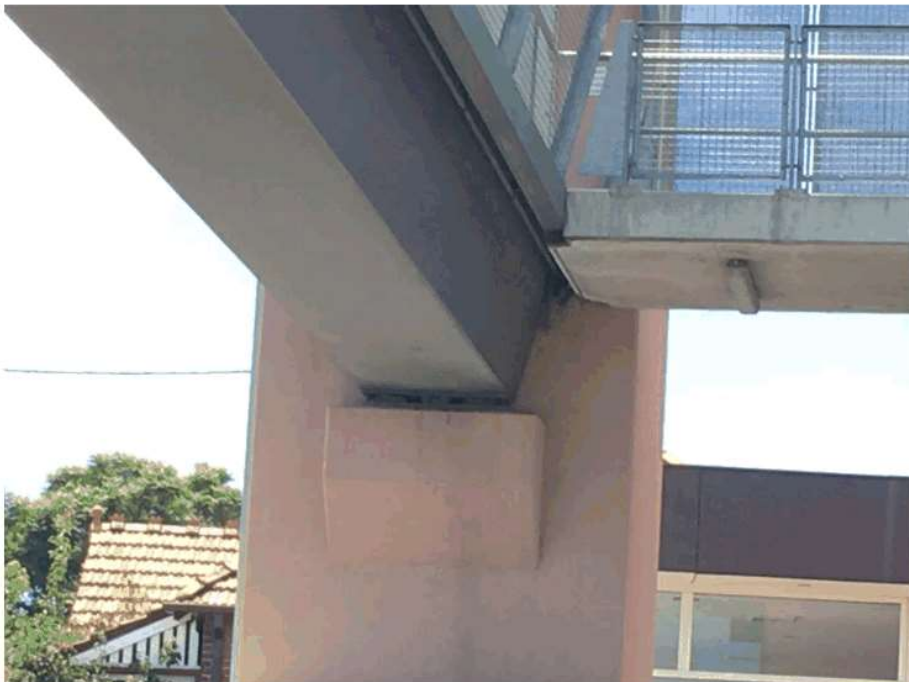
Bland Street Pedestrian Bridge – Northern abutment and bearing

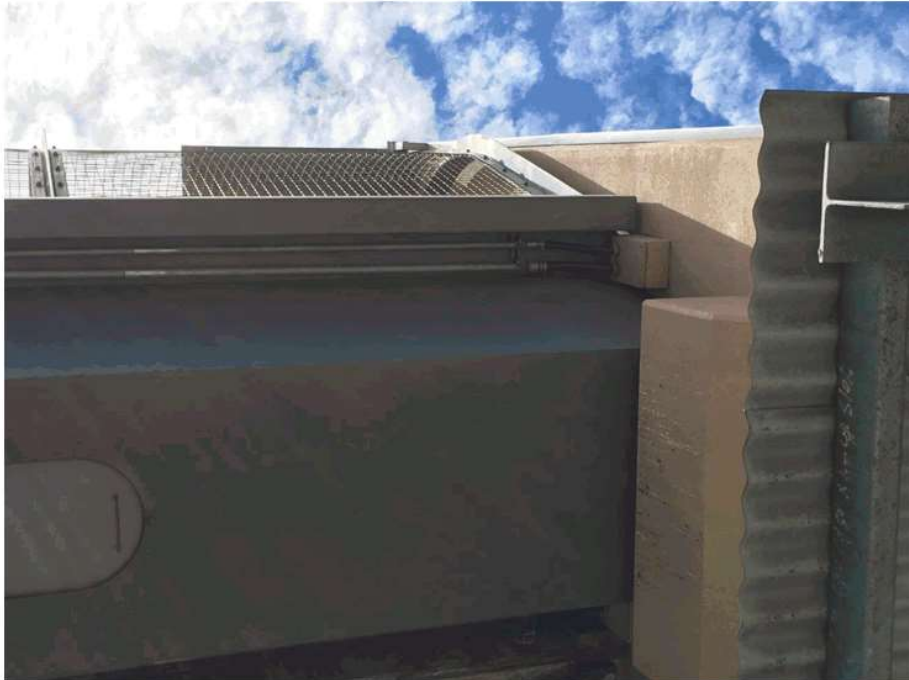
Bland Street Pedestrian Bridge – Southern abutment

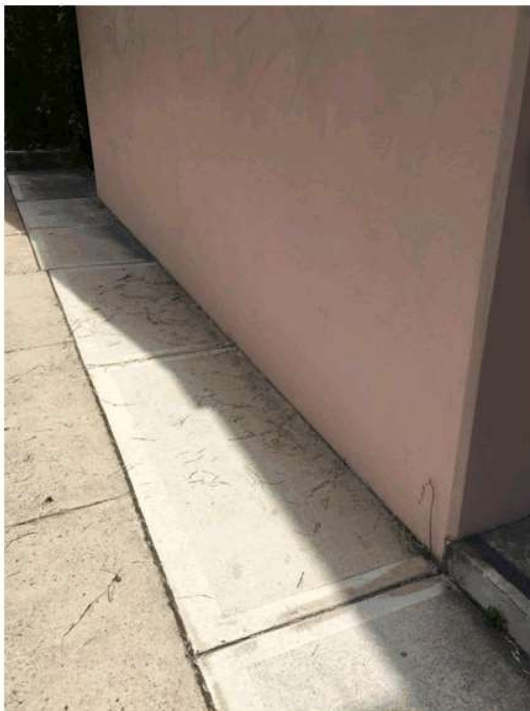
Bland Street Pedestrian Bridge – southern access stair support

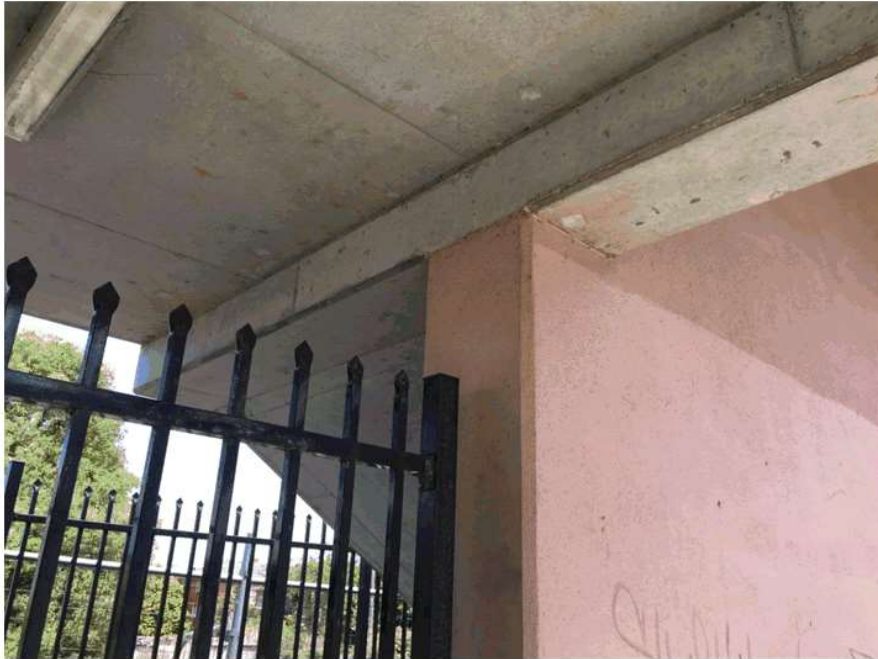
Bland Street Pedestrian Bridge – southern access stair support

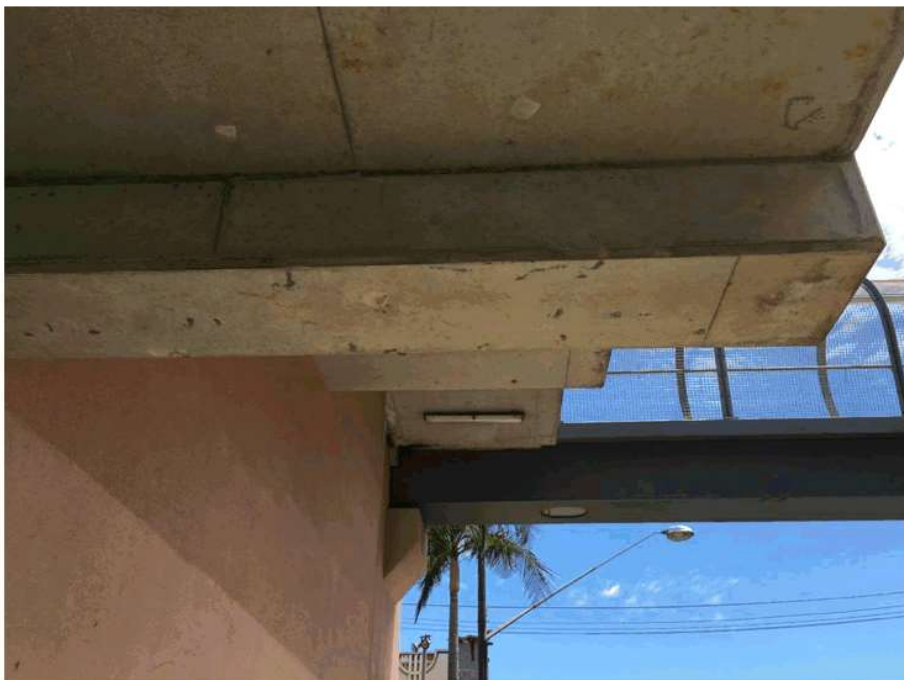
Bland Street Pedestrian Bridge – southern access stair

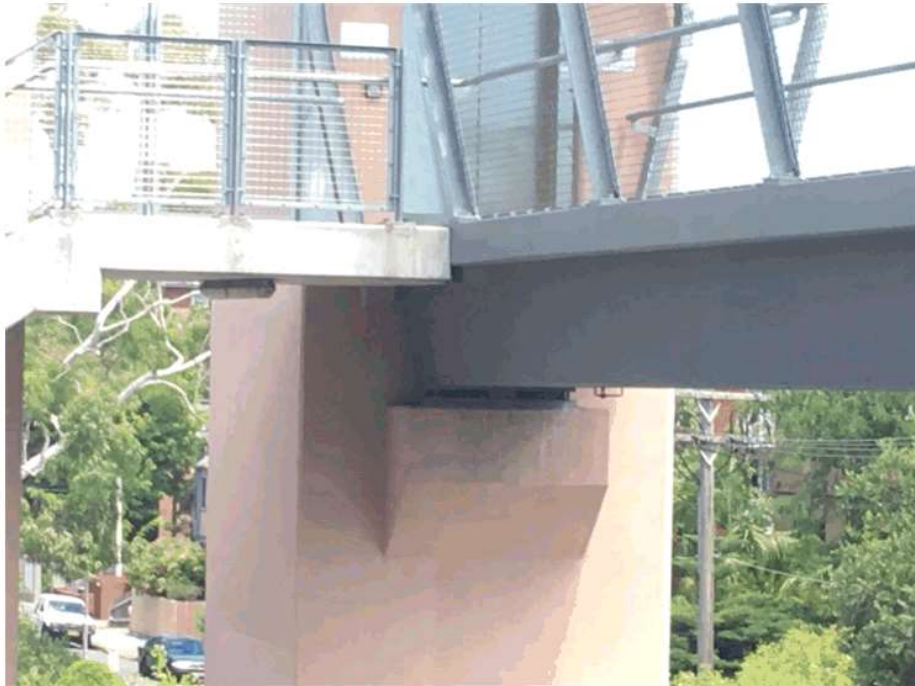
Bland Street Pedestrian Bridge – Southern abutment and bearing

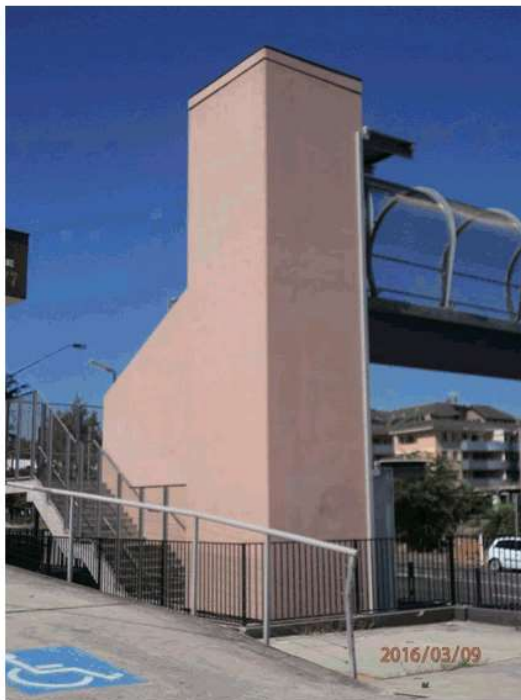
Bland Street Pedestrian Bridge – northern abutment

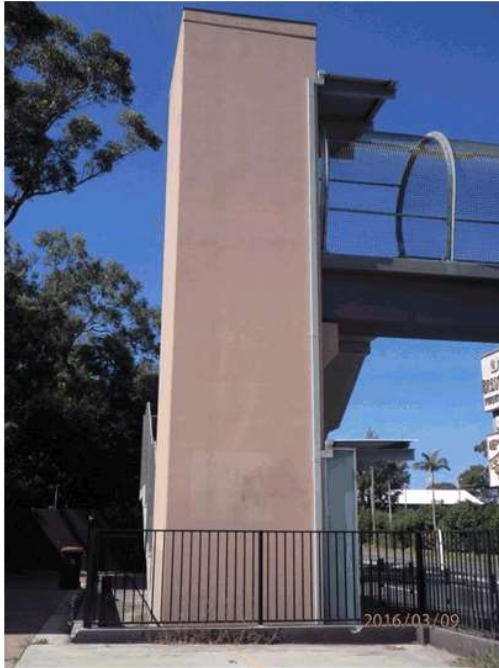
Bland Street Pedestrian Bridge – northern abutment

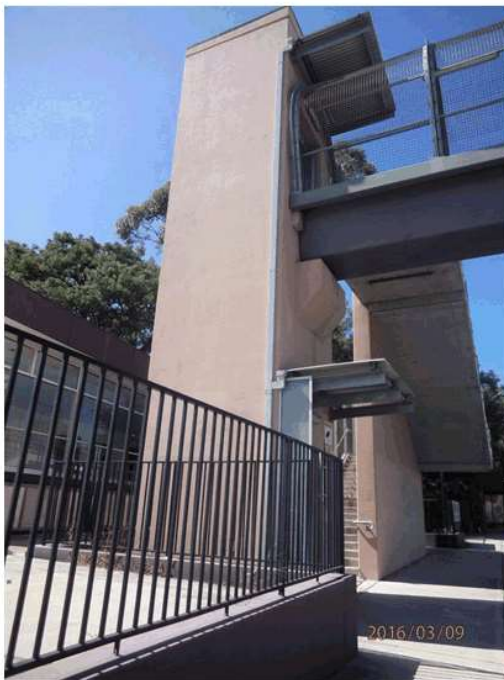
Bland Street Pedestrian Bridge – northern abutment

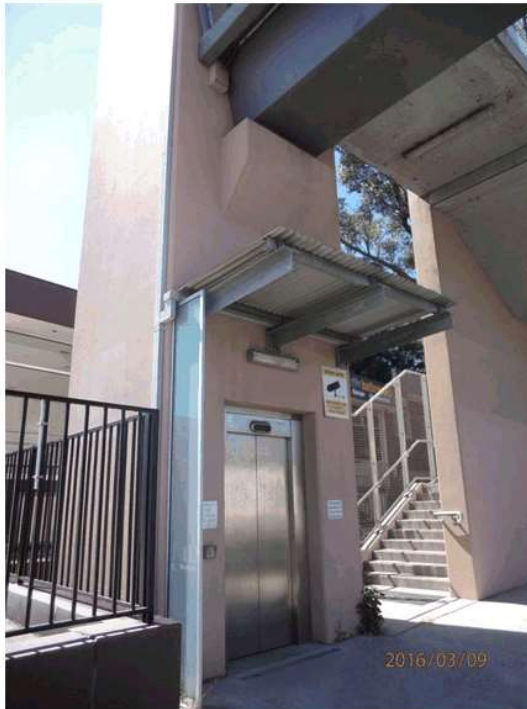
Bland Street Pedestrian Bridge – northern abutment

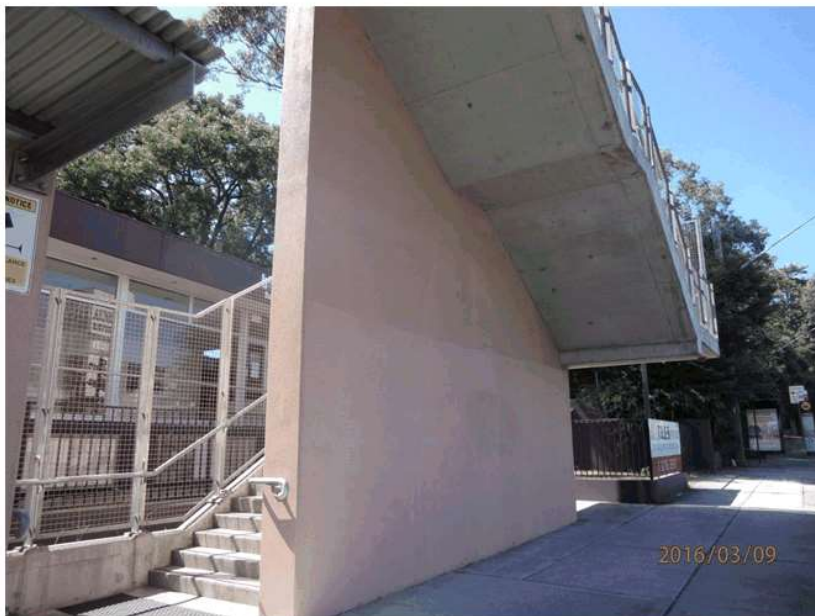
Bland Street Pedestrian Bridge – northern wall

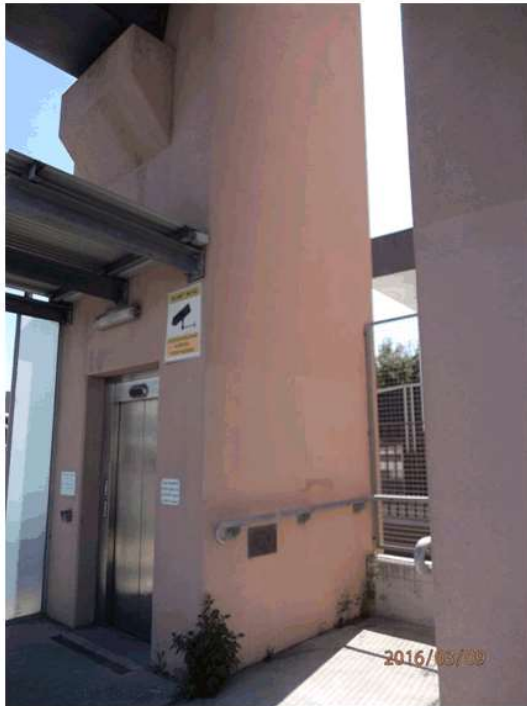
Bland Street Pedestrian Bridge – northern abutment

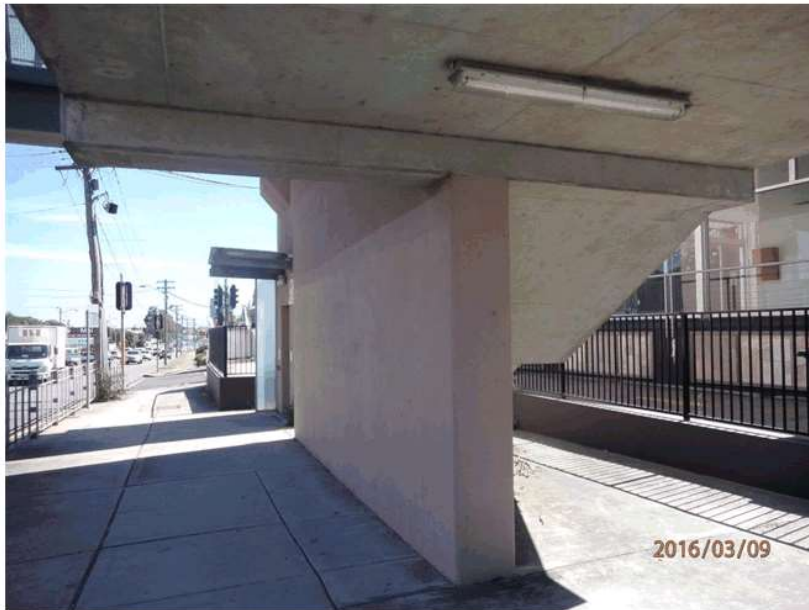
Bland Street Pedestrian Bridge – northern abutment

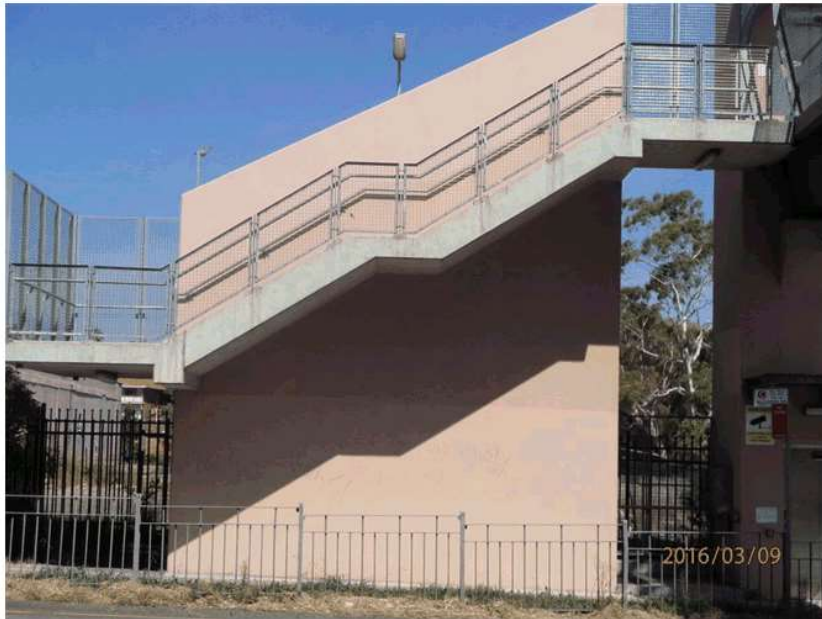
Bland Street Pedestrian Bridge – southern wall

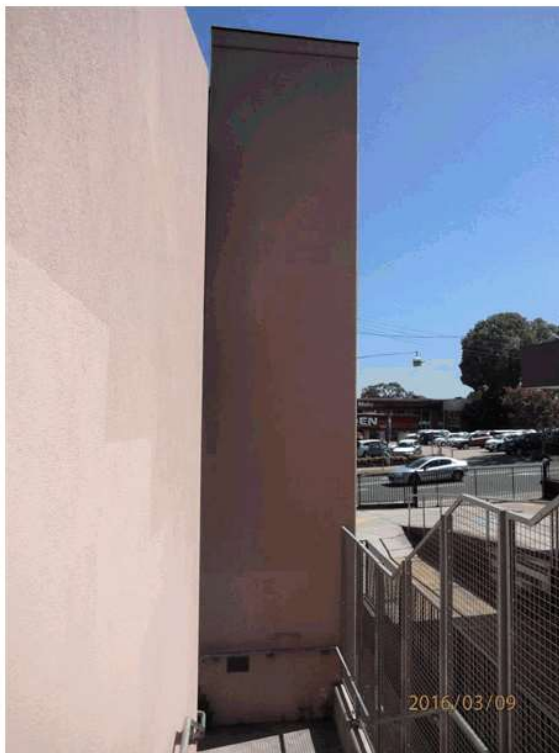
Bland Street Pedestrian Bridge – northern staircae

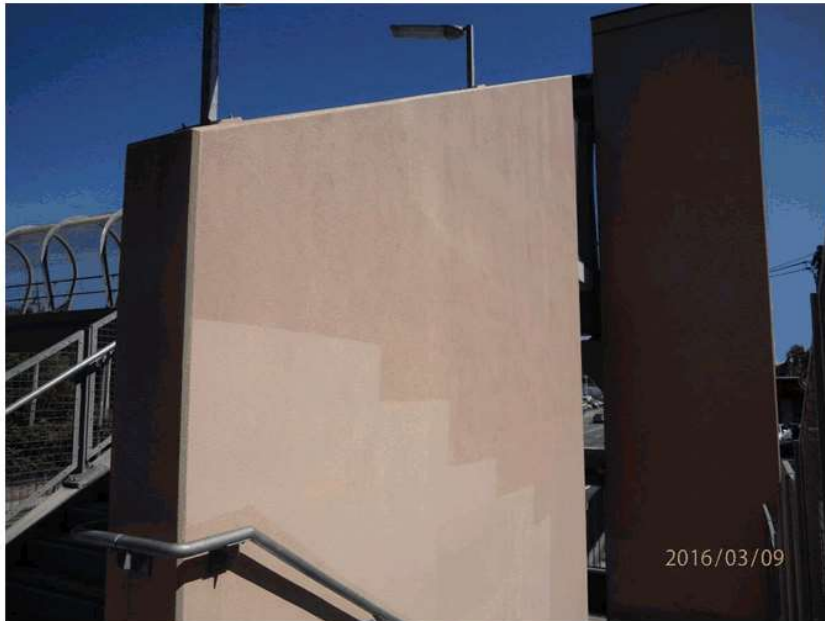
Bland Street Pedestrian Bridge – northern staircae

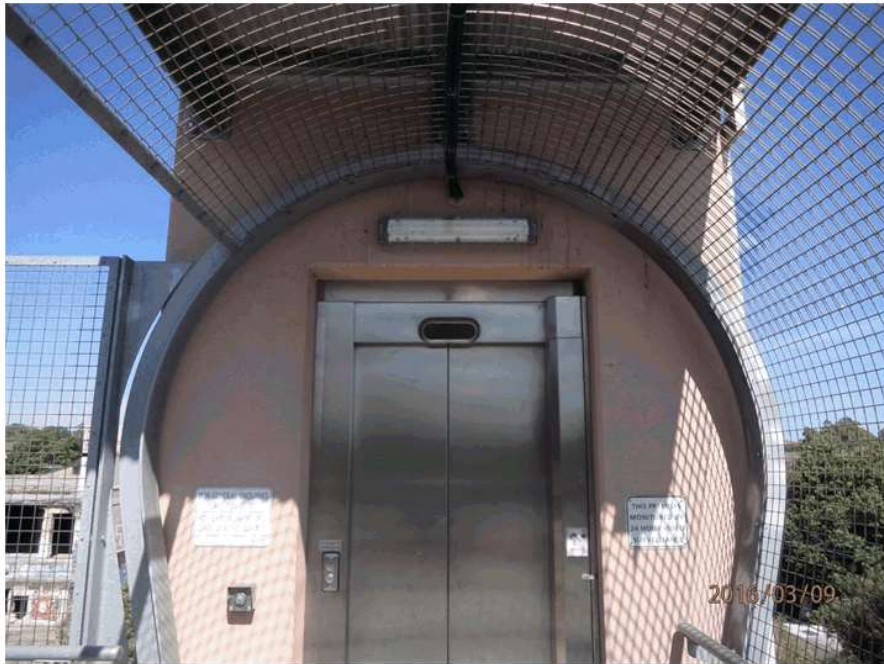
Bland Street Pedestrian Bridge – southern abutment

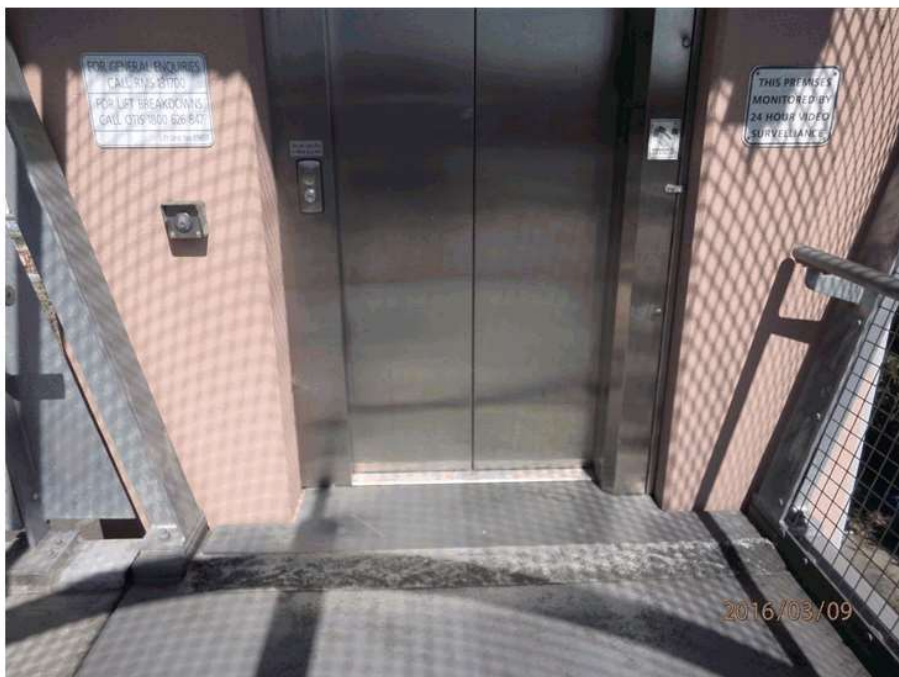
Bland Street Pedestrian Bridge – southern abutment

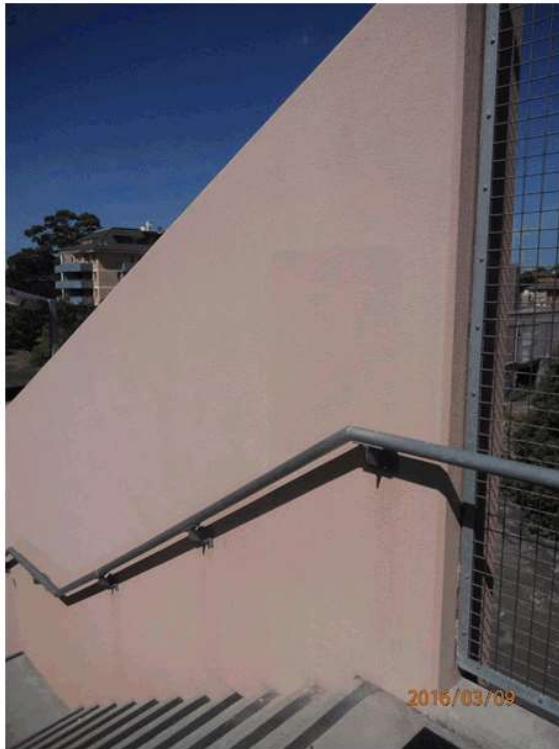
Bland Street Pedestrian Bridge – southern wall

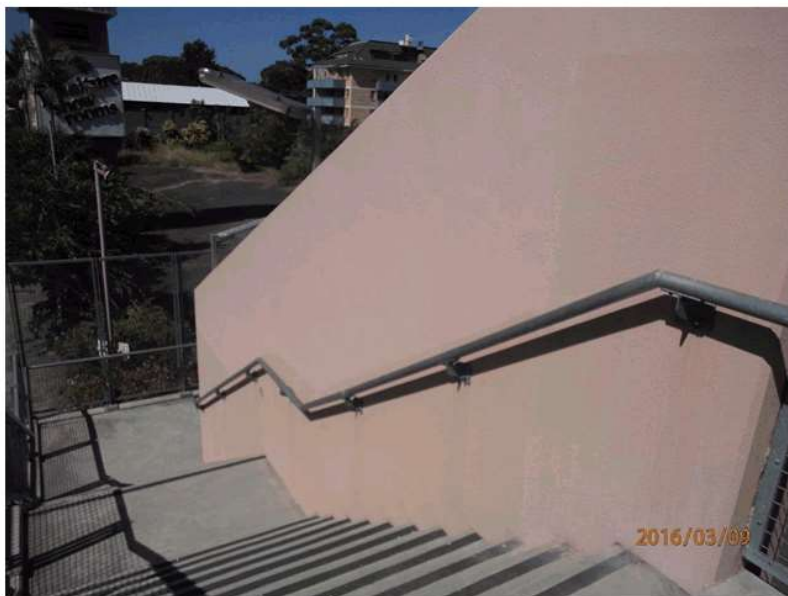
Bland Street Pedestrian Bridge – southern wall

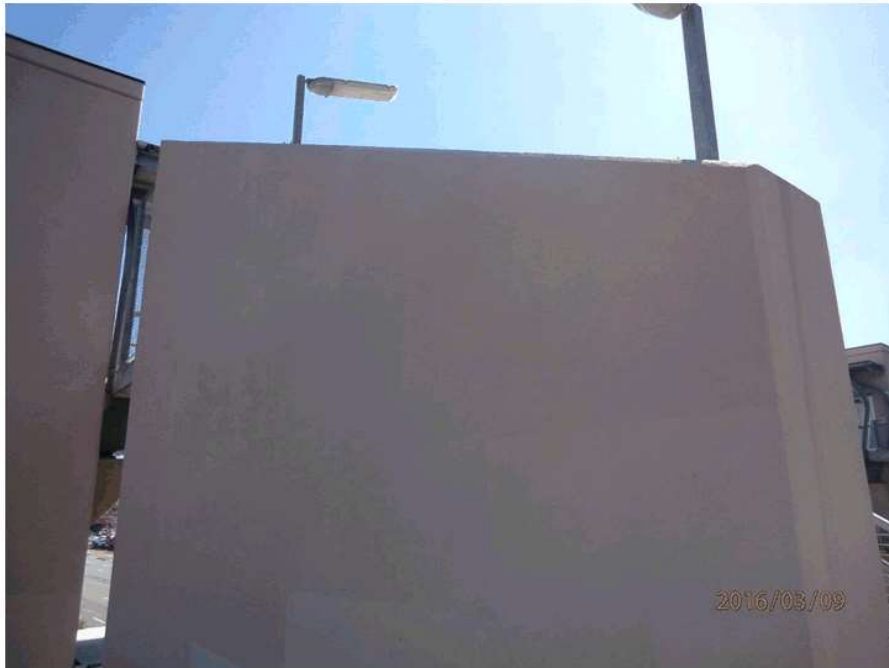
Bland Street Pedestrian Bridge – southern wall

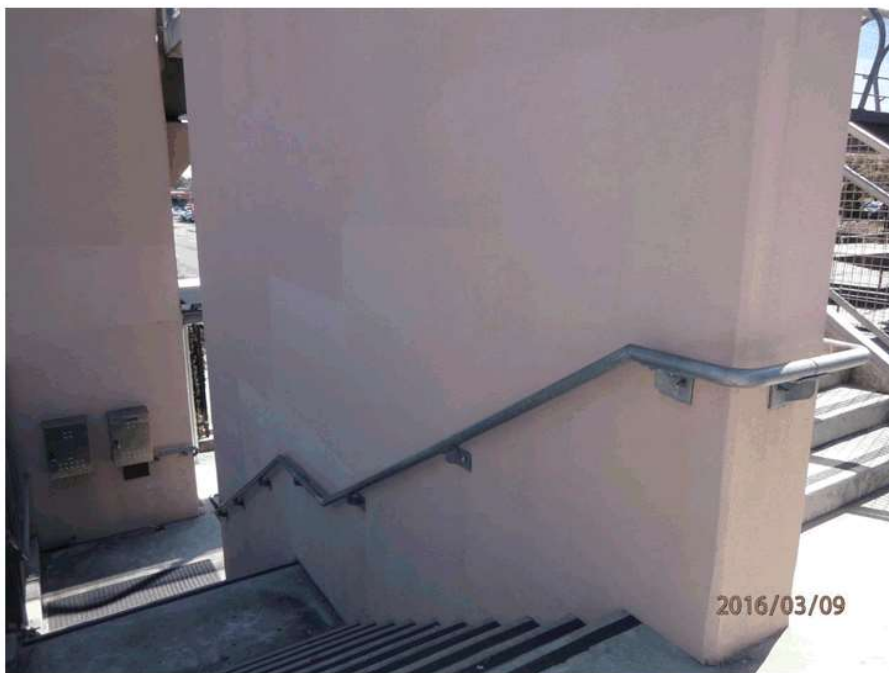
Bland Street Pedestrian Bridge – southern wall

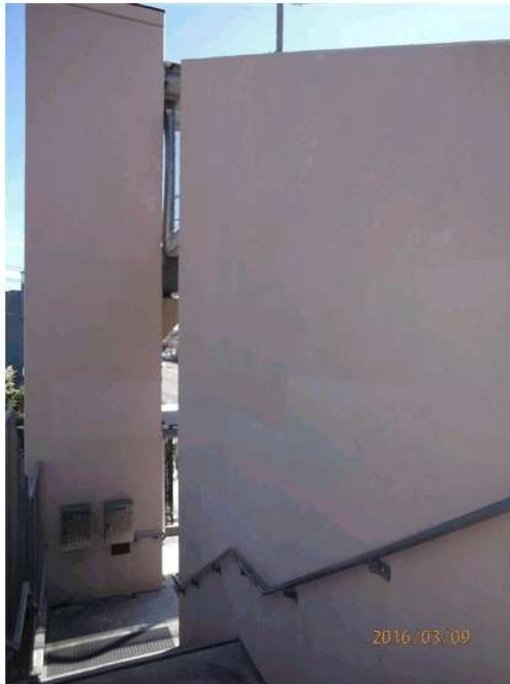
Bland Street Pedestrian Bridge – southern wall

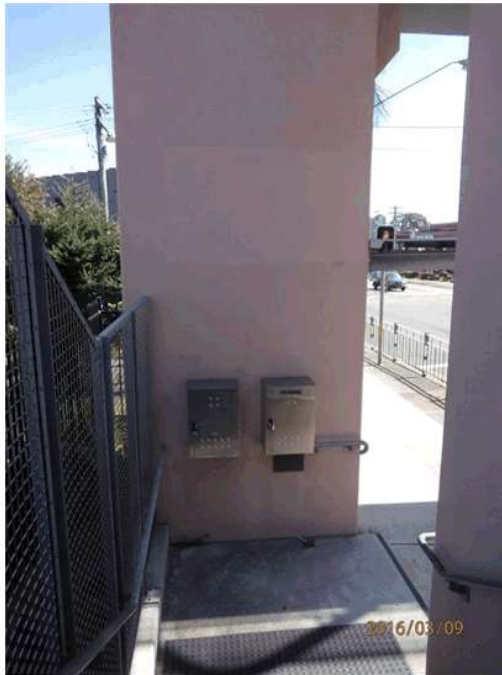
Bland Street Pedestrian Bridge – southern wall

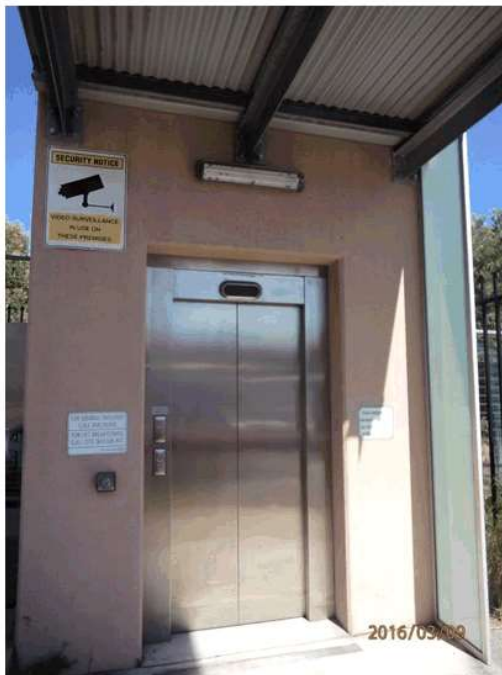
Bland Street Pedestrian Bridge – southern abutment

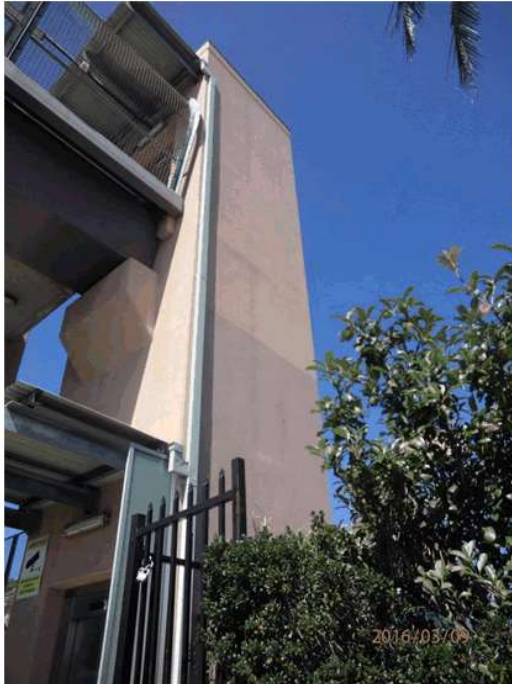
Bland Street Pedestrian Bridge – southern abutment

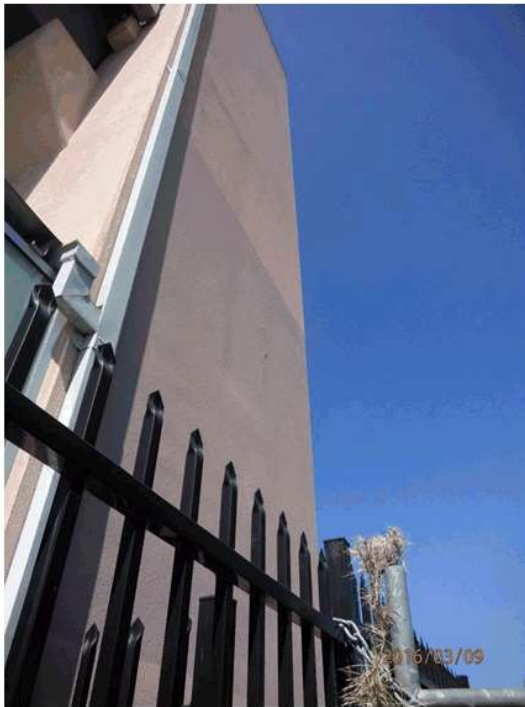
Bland Street Pedestrian Bridge – southern abutment

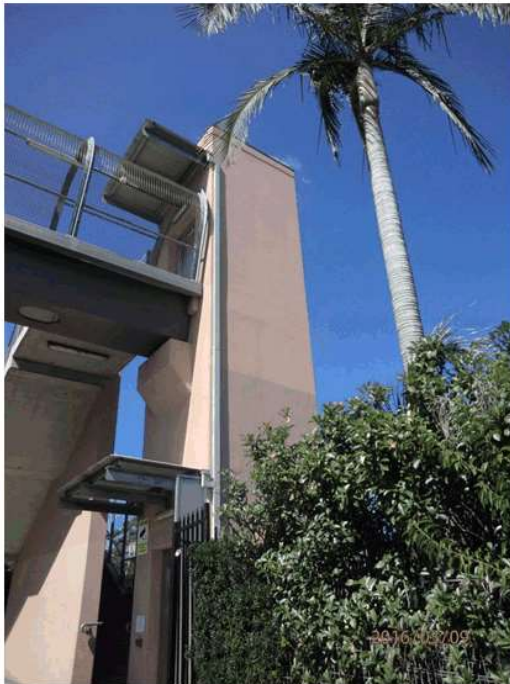
Bland Street Pedestrian Bridge – southern abutment

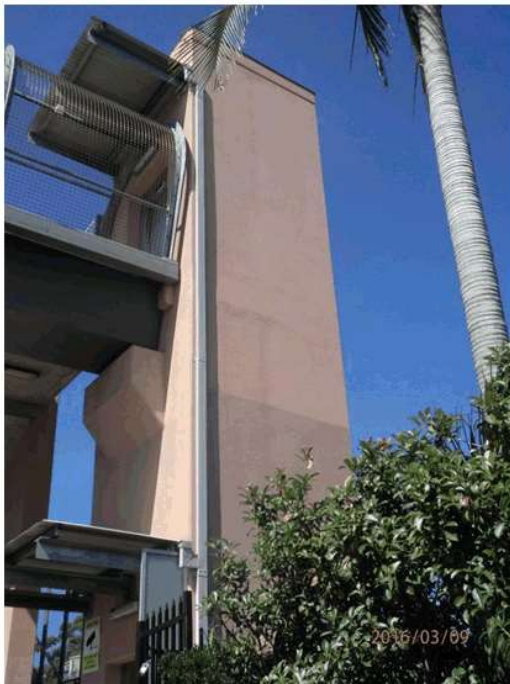
Bland Street Pedestrian Bridge – southern abutment

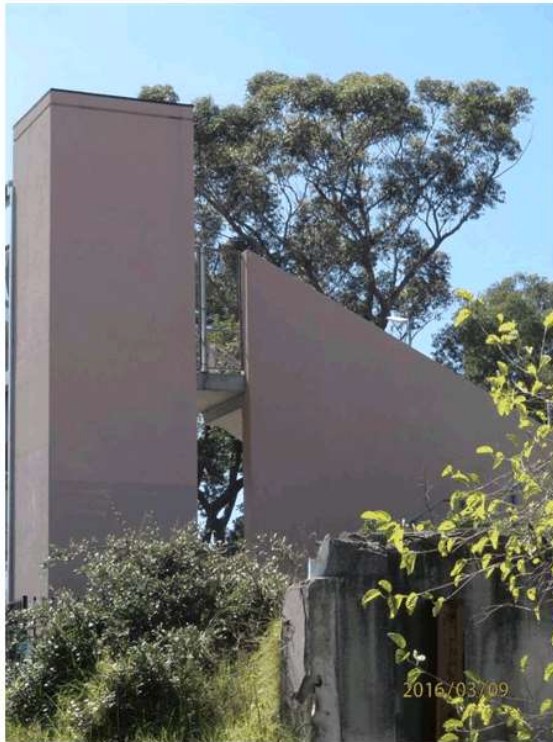
Bland Street Pedestrian Bridge – southern abutment
